Access Compliance Report

Public Rights-of-Way

(Curb Ramps)

Intersection ID: 15267	Main Street: EAST_BV	Cross Street: FLORAL_AV	Location: SW
ADA ID: 58DAF762B999	Ramp Type: PerpDiag	Initial Pass/Fail: Fail	Overall Compliance: No
Severity Score: 12.5			
Codes/Mitigation Info/Possible Solution		Field Measurements/Component Compliance

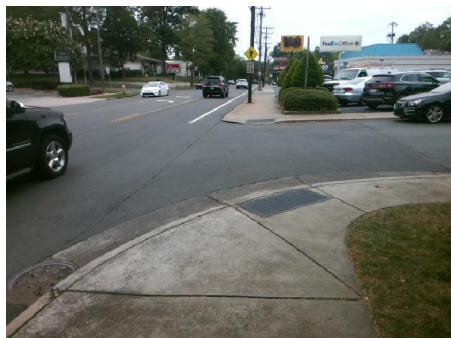
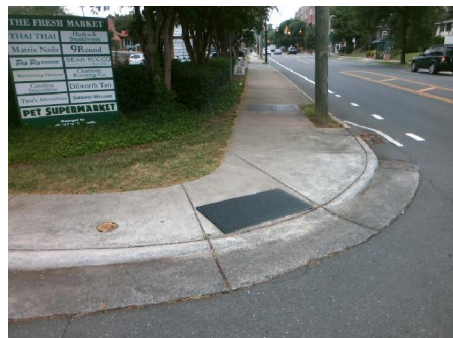
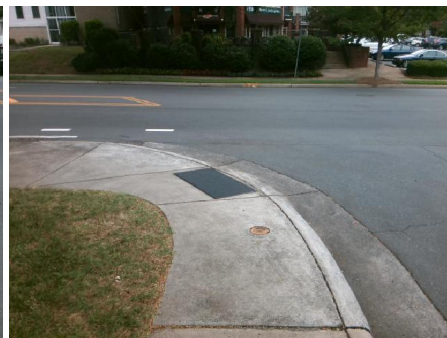
Not Found, R304.5.3

Compliance	Description	Data	Compliance	Description	Data
N/A	Ramp Length (in)	53.0	Yes	Ramp Slope (%)	7.5
Yes	Ramp Width (in)	49.0	No	Ramp XSlope (%)	5.2
N/A	Flare Type LT	N/A	N/A	Flare Type RT	N/A
N/A	Flare Slope LT (%)	N/A	N/A	Flare Slope RT (%)	N/A
N/A	Flare Traversable LT?	N/A	N/A	Flare Traversable RT?	N/A
N/A	Landing Length (in)	N/A	N/A	DWS Provided?	N/A
N/A	Landing Width (in)	N/A	N/A	DWS Contrast?	N/A
N/A	Landing Slope (%)	N/A	N/A	DWS Length (in)	N/A
N/A	Landing X Slope (%)	N/A	N/A	DWS Full Width?	N/A
N/A	Landing Curb? (Y/N)	N/A	N/A	DWS Offset (in)	N/A
N/A	Shared Landing?	N/A			
N/A	Gutter Ponding?	N/A	N/A	Gutter Slope (%)	N/A
N/A	Gutter Lip Ht (in)	N/A	N/A	Gutter X Slope (%)	N/A
N/A	Painted X Walk1?	No	N/A	Painted X Walk2?	No
	X Walk 1 Direction	To SE		X Walk 2 Direction	To NE
N/A	X Walk 1 Width (in)	N/A	N/A	X Walk 2 Width (in)	N/A
	X Walk 1 Slope (%)	0.2		X Walk 2 Slope (%)	1.2
	X Walk 1 X Slope (%)	1.5		X Walk 2 X Slope (%)	0.5

N/A	Ramp inside XWalk1?	N/A	N/A	Ramp inside XWalk2?	N/A
	Road Slope (%)	0.5	N/A	Clear Space?	N/A
	Road X Slope (%)	0.0	N/A	Clear Space to XWalk (in)	N/A
N/A	Any Obstructions?	N/A	N/A	Storm Grate/Utility Hazard?	N/A
	Obstruction Type			Storm Grate/Utility Type	
		N/A			N/A
		Yes		Surface Condition? (G/P)	Good

Remove & Replace Curb Ramp With Two New Directional Ramps or Equivalent.
