# Access Compliance Report

## Public Rights-of-Way

### (Curb Ramps)

Intersection ID: 14373	Main Street: EAST_BV	Cross Street: LYNDHURST_AV	Location: SW
ADA ID: 58DDAAA798E0	Ramp Type: Directional1	Initial Pass/Fail: Fail	Overall Compliance: No
		Severity Score: 12.5

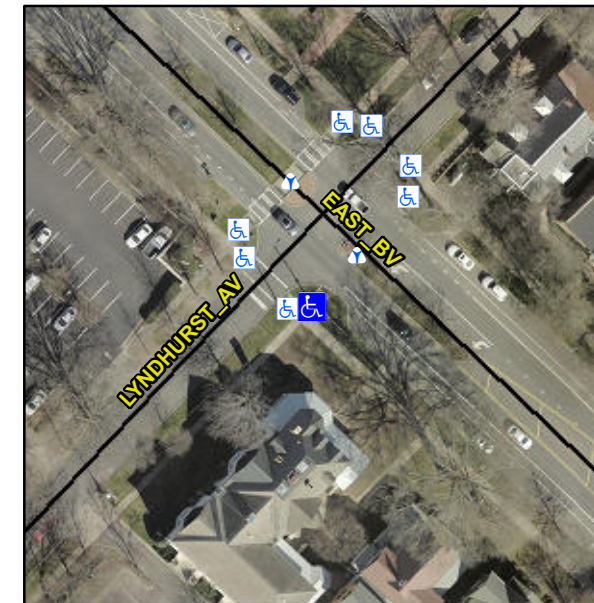
Compliance	Description	Data	Compliance	Description	Data
N/A	Ramp Length (in)	71.0	N/A	Grade Break?	N/A
Yes	Ramp Width (in)	72.0	N/A	Grade Break Slope (%)	0.0
No	Ramp Slope (%)	8.9	N/A	Grade Break XSlope (%)	0.0
Yes	Ramp XSlope (%)	1.8			
N/A	Flare Type LT	N/A	N/A	Flare Type RT	N/A
N/A	Flare Slope LT (%)	N/A	N/A	Flare Slope RT (%)	0.0
N/A	Flare Traversable LT?	N/A	N/A	Flare Traversable RT?	N/A
N/A	Landing Length (in)	0.0	N/A	DWS Provided?	N/A
N/A	Landing Width (in)	0.0	N/A	DWS Contrast?	N/A
N/A	Landing Slope (%)	0.0	N/A	DWS Length (in)	N/A
N/A	Landing X Slope (%)	0.0	N/A	DWS Full Width?	N/A
N/A	Landing Curb? (Y/N)	N/A	N/A	DWS Offset LT (in)	N/A
N/A	Shared Landing?	N/A	N/A	DWS Offset RT (in)	N/A
N/A	Gutter Ponding?	0.0	N/A	Gutter Slope (%)	N/A
N/A	Gutter Lip Ht (in)	0.0	N/A	Gutter X Slope (%)	N/A
N/A	Painted X Walk1?	No		Road Slope (%)	4.0
	X Walk 1 Direction	To NE		Road X Slope (%)	0.8
	X Walk 1 Width (in)	N/A		Clear Space?	N/A

X Walk 1 Slope (%)	4.0	N/A	Clear Space to XWalk (in)	N/A
	X Walk 1 X Slope (%)	0.8	N/A	Storm Grate/Utility Hazard?	N/A
N/A	Ramp inside XWalk1?	N/A		Storm Grate/Utility Type	
N/A	Any Obstructions?	N/A			N/A
	Obstruction Type		Yes	Surface Condition? (G/P)	Good
			N/A	Curb Slope (%)	4.5

**Remove & Replace Entire Ramp.**

**R304.2.2**
