# Access Compliance Report

## Public Rights-of-Way

### (Curb Ramps)

Intersection ID: 12073	Main Street: E_11TH_ST	Cross Street: N_CALDWELL_ST	Location: E
ADA ID: 58EE685871A7	Ramp Type: PerpDiag	Initial Pass/Fail: Fail	Overall Compliance: No
Severity Score: 21.25			
Codes/Mitigation Info/Possible Solution		Field Measurements/Component Compliance

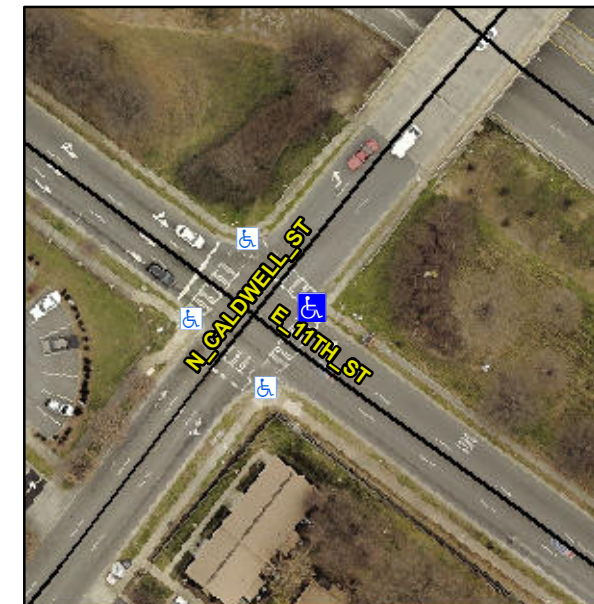
**Not Found, R304.5.1, R304.2.2**

Compliance	Description	Data	Compliance	Description	Data
N/A	Ramp Length (in)	52.0	No	Ramp Slope (%)	8.7
No	Ramp Width (in)	47.5	Yes	Ramp XSlope (%)	0.5
N/A	Flare Type LT	N/A	N/A	Flare Type RT	N/A
N/A	Flare Slope LT (%)	N/A	N/A	Flare Slope RT (%)	N/A
N/A	Flare Traversable LT?	N/A	N/A	Flare Traversable RT?	N/A
N/A	Landing Length (in)	N/A	N/A	DWS Provided?	N/A
N/A	Landing Width (in)	N/A	N/A	DWS Contrast?	N/A
N/A	Landing Slope (%)	N/A	N/A	DWS Length (in)	N/A
N/A	Landing X Slope (%)	N/A	N/A	DWS Full Width?	N/A
N/A	Landing Curb? (Y/N)	N/A	N/A	DWS Offset (in)	N/A
N/A	Shared Landing?	N/A			
N/A	Gutter Ponding?	N/A	N/A	Gutter Slope (%)	N/A
N/A	Gutter Lip Ht (in)	N/A	N/A	Gutter X Slope (%)	N/A
N/A	Painted X Walk1?	Yes	N/A	Painted X Walk2?	Yes
	X Walk 1 Direction	To NW		X Walk 2 Direction	To SW
N/A	X Walk 1 Width (in)	101.0	N/A	X Walk 2 Width (in)	109.0
	X Walk 1 Slope (%)	2.2		X Walk 2 Slope (%)	1.1
	X Walk 1 X Slope (%)	0.9		X Walk 2 X Slope (%)	3.1

N/A	Ramp inside XWalk1?	Yes	N/A	Ramp inside XWalk2?	Yes
	Road Slope (%)	0.7	N/A	Clear Space?	N/A
	Road X Slope (%)	6.4	N/A	Clear Space to XWalk (in)	N/A
N/A	Any Obstructions?	N/A	N/A	Storm Grate/Utility Hazard?	N/A
	Obstruction Type			Storm Grate/Utility Type	
		N/A			N/A
		Yes		Surface Condition? (G/P)	Good

**Remove & Replace Curb Ramp With Two New Directional Ramps or Equivalent.**
