# Access Compliance Report

## Public Rights-of-Way

### (Curb Ramps)

Intersection ID: 6357	Main Street: CENTURY_OAKS_LN	Cross Street: WATERSTONE_LN	Location: N
ADA ID: 58EF4302FF9E	Ramp Type: Directional1	Initial Pass/Fail: Fail	Overall Compliance: No
			Severity Score: 46.25

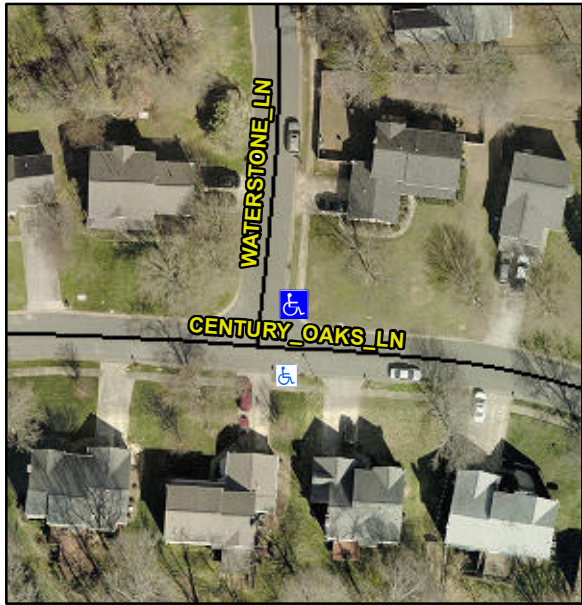
<div>Street 1 Name<div>CENTURY OAKS LN</div></div> <div>Stop Condition-Street 1<div>None</div></div> <div>Street 2 Name<div>N/A</div></div> <div>Stop Condition-Street 2<div>N/A</div></div>	Possible Solutions:		Compliance	Description	Data	Compliance	Description	Data
	Remove & Replace Entire Ramp.		N/A	Ramp Length (in)	55.0	N/A	Grade Break?	N/A
			No	Ramp Width (in)	42.0	N/A	Grade Break Slope (%)	0.0
			No	Ramp Slope (%)	13.0	N/A	Grade Break XSlope (%)	0.0
			No	Ramp XSlope (%)	5.3			
			N/A	Flare Type LT	N/A	N/A	Flare Type RT	N/A
			N/A	Flare Slope LT (%)	N/A	N/A	Flare Slope RT (%)	0.0
			N/A	Flare Traversable LT?	N/A	N/A	Flare Traversable RT?	N/A
			N/A	Landing Length (in)	0.0	N/A	DWS Provided?	N/A
			N/A	Landing Width (in)	0.0	N/A	DWS Contrast?	N/A
			N/A	Landing Slope (%)	0.0	N/A	DWS Length (in)	N/A
			N/A	Landing X Slope (%)	0.0	N/A	DWS Full Width?	N/A

N/A	Landing Curb? (Y/N)	N/A	N/A	DWS Offset LT (in)	N/A
			N/A	Shared Landing?	N/A	N/A	DWS Offset RT (in)	N/A
			N/A	Gutter Ponding?	0.0	N/A	Gutter Slope (%)	N/A
			N/A	Gutter Lip Ht (in)	0.0	N/A	Gutter X Slope (%)	N/A
			N/A	Painted X Walk1?	No		Road Slope (%)	0.0
				X Walk 1 Direction	To S		Road X Slope (%)	2.6
				X Walk 1 Width (in)	N/A		Clear Space?	N/A
				X Walk 1 Slope (%)	0.0	N/A	Clear Space to XWalk (in)	N/A
				X Walk 1 X Slope (%)	2.6	N/A	Storm Grate/Utility Hazard?	N/A
			N/A	Ramp inside XWalk1?	N/A		Storm Grate/Utility Type	
			N/A	Any Obstructions?	N/A			N/A
				Obstruction Type		Yes	Surface Condition? (G/P)	Good
						N/A	Curb Slope (%)	10.1
Surveyor Notes:								
N/A								
PROW/ADA:								
R304.5.1, R304.2.2, R304.5.3								
Total Cost:		\$	1600.00
