Access Compliance Report

Public Rights-of-Way

(Curb Ramps)

Intersection ID: 13685	Main Street: S_MINT_ST	Cross Street: W_WORTHINGTON_AV	Location: SW
ADA ID: 58F38938F545	Ramp Type: PerpDiag	Initial Pass/Fail: Fail	Overall Compliance: No
		Severity Score: 12.5

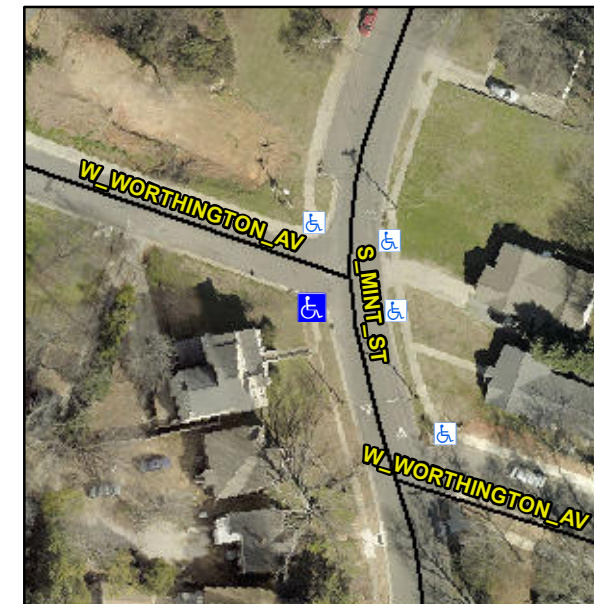
Not Found, R304.5.3

Compliance	Description	Data	Compliance	Description	Data
N/A	Ramp Length (in)	87.0	Yes	Ramp Slope (%)	5.5
Yes	Ramp Width (in)	48.0	No	Ramp XSlope (%)	5.1
N/A	Flare Type LT	N/A	N/A	Flare Type RT	N/A
N/A	Flare Slope LT (%)	N/A	N/A	Flare Slope RT (%)	N/A
N/A	Flare Traversable LT?	N/A	N/A	Flare Traversable RT?	N/A
N/A	Landing Length (in)	N/A	N/A	DWS Provided?	N/A
N/A	Landing Width (in)	N/A	N/A	DWS Contrast?	N/A
N/A	Landing Slope (%)	N/A	N/A	DWS Length (in)	N/A
N/A	Landing X Slope (%)	N/A	N/A	DWS Full Width?	N/A
N/A	Landing Curb? (Y/N)	N/A	N/A	DWS Offset (in)	N/A
N/A	Shared Landing?	N/A			
N/A	Gutter Ponding?	N/A	N/A	Gutter Slope (%)	N/A
N/A	Gutter Lip Ht (in)	N/A	N/A	Gutter X Slope (%)	N/A
N/A	Painted X Walk1?	No	N/A	Painted X Walk2?	No
	X Walk 1 Direction	To E		X Walk 2 Direction	To N
N/A	X Walk 1 Width (in)	N/A	N/A	X Walk 2 Width (in)	N/A
	X Walk 1 Slope (%)	2.9		X Walk 2 Slope (%)	1.6
	X Walk 1 X Slope (%)	0.1		X Walk 2 X Slope (%)	7.0

N/A	Ramp inside XWalk1?	N/A	N/A	Ramp inside XWalk2?	N/A
	Road Slope (%)	5.1	N/A	Clear Space?	N/A
	Road X Slope (%)	2.0	N/A	Clear Space to XWalk (in)	N/A
N/A	Any Obstructions?	N/A	N/A	Storm Grate/Utility Hazard?	N/A
	Obstruction Type			Storm Grate/Utility Type	
		N/A			N/A
		Yes		Surface Condition? (G/P)	Good

Remove & Replace Curb Ramp With Two New Directional Ramps or Equivalent.
