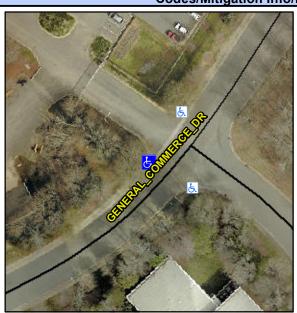
Intersection ID: 8746Main Street: GENERAL\_COMMERCE\_DRCross Street: INDUSTRIAL\_CENTER\_CRLocation:SWADA ID: 5908699BE34CRamp Type: PerpDiagInitial Pass/Fail: FailOverall Compliance: NoSeverity Score:30

Not Found, R304.5.1, R304.2.2

Compliance Description		Data	Compliance		Description	Data
N/A	Ramp Length (in)	59.5	No	Ramp	Slope (%)	9.0
No	Ramp Width (in)	35.0	Yes	Ramp	XSlope (%)	0.7
N/A	Flare Type LT	N/A	N/A	Flare	Type RT	N/A
N/A	Flare Slope LT (%)	N/A	N/A	Flare	Slope RT (%)	N/A
N/A	Flare Traversable LT?	N/A	N/A	Flare	Traversable RT?	N/A
N/A	Landing Length (in)	N/A	N/A	DWS	Provided?	N/A
N/A	Landing Width (in)	N/A	N/A	DWS	Contrast?	N/A
N/A	Landing Slope (%)	N/A	N/A	DWS	Length (in)	N/A
N/A	Landing X Slope (%)	N/A	N/A	DWS	Full Width?	N/A
N/A	Landing Curb? (Y/N)	N/A	N/A	DWS	Offset (in)	N/A
N/A	Shared Landing?	N/A				
N/A	Gutter Ponding?	N/A	N/A	Gutte	r Slope (%)	N/A
N/A	Gutter Lip Ht (in)	N/A	N/A	Gutte	r X Slope (%)	N/A
N/A	Painted X Walk1?	No	N/A	Painte	ed X Walk2?	No
	X Walk 1 Direction	To SE		X Wa	lk 2 Direction	To NE
N/A	X Walk 1 Width (in)	N/A	N/A	X Wa	lk 2 Width (in)	N/A
	X Walk 1 Slope (%)	4.2		X Wa	lk 2 Slope (%)	0.1
	X Walk 1 X Slope (%)	0.1		X Wa	lk 2 X Slope (%)	5.1

N/A	Ramp inside XWalk1?	N/A	N/A	Ramp	inside XWalk2?	N/A
	Road Slope (%)	0.1	N/A	Clear	Space?	N/A
	Road X Slope (%)	4.5	N/A	Clear	Space to XWalk (in)	N/A
N/A	Any Obstructions?	N/A	N/A	Storm	Grate/Utility Hazard?	N/A
	Obstruction Type		l	Storm	Grate/Utility Type	
		N/A				N/A

Remove & Replace Curb Ramp With Two New Directional Ramps or Equivalent.
