## Access Compliance Report Public Rights-of-Way (Curb Ramps)

Intersection ID: 29121Main Street: APPLE\_GLEN\_LNCross Street: HIGHLAND\_PARK\_DRLocation:NEADA ID: 59110BFA83CCRamp Type: PerpInitial Pass/Fail: FailOverall Compliance: NoSeverity Score: 12.5

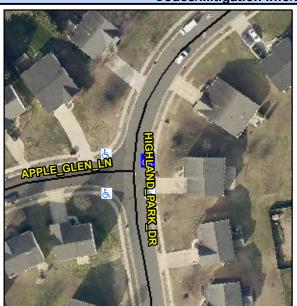
Compliance Description Data		Data	Compliance Description		Data
N/A	Ramp Length (in)	48.0	Yes	Ramp Slope (%)	6.0
Yes	Ramp Width (in)	48.0	No	Ramp XSlope (%)	5.9
N/A	Flare Type LT	N/A	N/A	Flare Type RT	N/A
N/A	Flare Slope LT (%)	N/A	N/A	Flare Slope RT (%)	N/A
N/A	Flare Traversable LT?	N/A	N/A	Flare Traversable RT?	N/A
N/A	Landing Length (in)	N/A	N/A	DWS Provided?	N/A
N/A	Landing Width (in)	N/A	N/A	DWS Contrast?	N/A
N/A	Landing Slope (%)	N/A	N/A	DWS Length (in)	N/A
N/A	Landing X Slope (%)	N/A	N/A	DWS Full Width?	N/A
N/A	Landing Curb? (Y/N)	N/A	N/A	DWS Offset (in)	N/A
N/A	Shared Landing?	N/A			
N/A	Gutter Ponding?	N/A	N/A	Gutter Slope (%)	N/A
N/A	Gutter Lip Ht (in)	N/A	N/A	Gutter X Slope (%)	N/A
N/A	Painted X Walk1?	No	N/A	Painted X Walk2?	N/A
	X Walk 1 Direction	To W		X Walk 2 Direction	N/A
N/A	X Walk 1 Width (in)	N/A	N/A	X Walk 2 Width (in)	N/A
	X Walk 1 Slope (%)	2.4		X Walk 2 Slope (%)	N/A
	X Walk 1 X Slope (%)	5.6		X Walk 2 X Slope (%)	N/A

N/A	Ramp inside XWalk1?	N/A	N/A	Ramp inside XWalk2?	N/A
	Road Slope (%)	N/A	N/A	Clear Space?	N/A
	Road X Slope (%)	N/A	N/A	Clear Space to XWalk (in)	N/A
N/A	Any Obstructions?	N/A	N/A	Storm Grate/Utility Hazard?	N/A
	Obstruction Type			Storm Grate/Utility Type	
		N/A			N/A
			Yes	Surface Condition? (G/P)	Good

Possible Solution	
Possible Solutions:	9
Remove & Replace Entire Ramp.	N
·	Y
	N
	N
	N
	N
Surveyor Notes:	N
N/A	N
	N
	N
	N
PROW/ADA:	N
R304.5.3	N
	N
	N
