# Access Compliance Report

## Public Rights-of-Way

### (Curb Ramps)

Intersection ID: 12968	Main Street: LINCOLN_ST	Cross Street: S_MINT_ST	Location: S
ADA ID: 591BDEB77442	Ramp Type: PerpDiag	Initial Pass/Fail: Fail	Overall Compliance: No
		Severity Score: 25

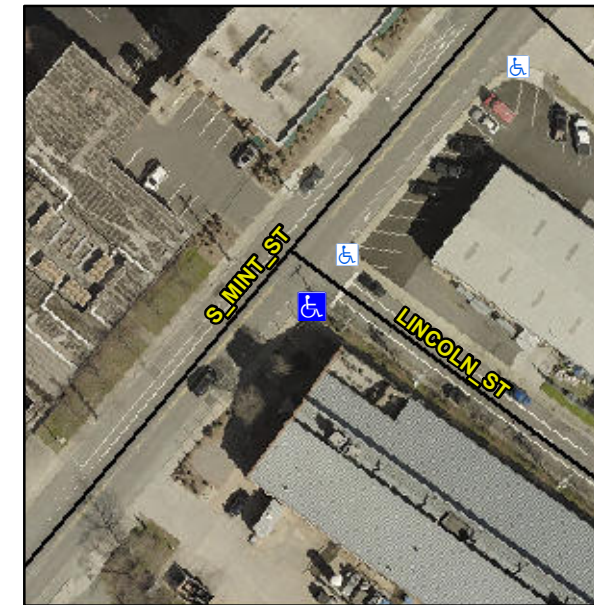
Compliance	Description	Data	Compliance	Description	Data
N/A	Ramp Length (in)	26.0	Yes	Ramp Slope (%)	5.3
Yes	Ramp Width (in)	48.0	No	Ramp XSlope (%)	9.0
N/A	Flare Type LT	N/A	N/A	Flare Type RT	N/A
N/A	Flare Slope LT (%)	N/A	N/A	Flare Slope RT (%)	N/A
N/A	Flare Traversable LT?	N/A	N/A	Flare Traversable RT?	N/A
N/A	Landing Length (in)	N/A	N/A	DWS Provided?	N/A
N/A	Landing Width (in)	N/A	N/A	DWS Contrast?	N/A
N/A	Landing Slope (%)	N/A	N/A	DWS Length (in)	N/A
N/A	Landing X Slope (%)	N/A	N/A	DWS Full Width?	N/A
N/A	Landing Curb? (Y/N)	N/A	N/A	DWS Offset (in)	N/A
N/A	Shared Landing?	N/A			
N/A	Gutter Ponding?	N/A	N/A	Gutter Slope (%)	N/A
N/A	Gutter Lip Ht (in)	N/A	N/A	Gutter X Slope (%)	N/A
N/A	Painted X Walk1?	No	N/A	Painted X Walk2?	No
	X Walk 1 Direction	To NE		X Walk 2 Direction	To NW
N/A	X Walk 1 Width (in)	N/A	N/A	X Walk 2 Width (in)	N/A
	X Walk 1 Slope (%)	2.1		X Walk 2 Slope (%)	6.6
	X Walk 1 X Slope (%)	5.5		X Walk 2 X Slope (%)	1.9

N/A	Ramp inside XWalk1?	N/A	N/A	Ramp inside XWalk2?	N/A
	Road Slope (%)	4.3	N/A	Clear Space?	N/A
	Road X Slope (%)	4.6	N/A	Clear Space to XWalk (in)	N/A
N/A	Any Obstructions?	N/A	N/A	Storm Grate/Utility Hazard?	N/A
	Obstruction Type			Storm Grate/Utility Type	
		N/A			N/A
			Yes	Surface Condition? (G/P)	Good

**Remove & Replace Curb Ramp With Two New Directional Ramps or Equivalent.**

**R304.5.3**
