Access Compliance Report

Public Rights-of-Way

(Curb Ramps)

Intersection ID: 51751	Main Street: GOLF_LINKS_DR	Cross Street: GOLF_LINKS_DR_N	Location: NE
ADA ID: 591FD18D9AC2	Ramp Type: PerpDiag	Initial Pass/Fail: Fail	Overall Compliance: No
Severity Score: 21.25			
Codes/Mitigation Info/Possible Solution		Field Measurements/Component Compliance

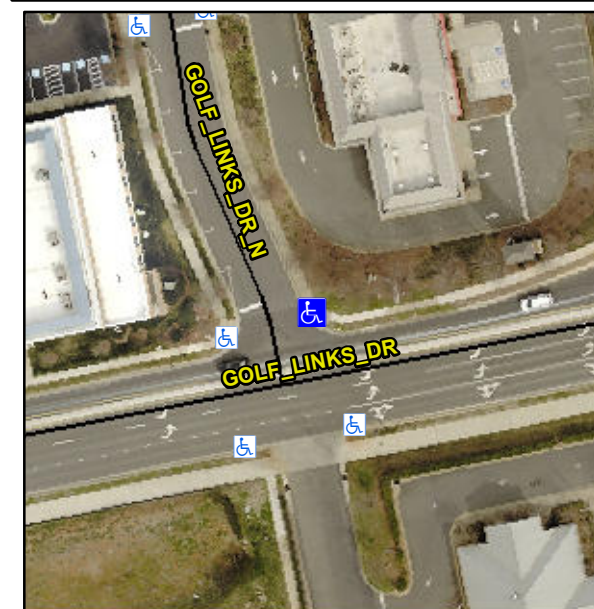
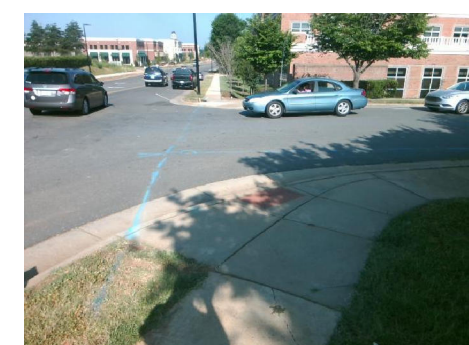
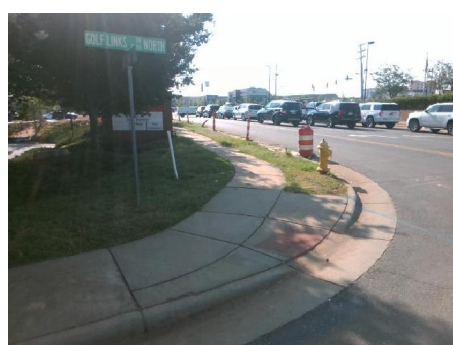
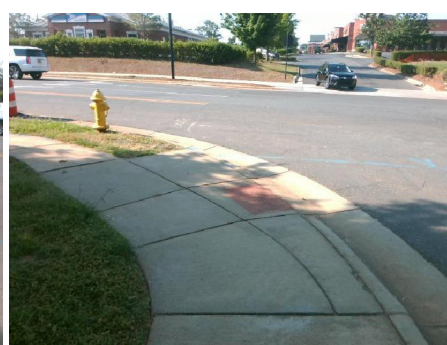
Not Found, R304.5.1, R304.5.3

Compliance	Description	Data	Compliance	Description	Data
N/A	Ramp Length (in)	47.0	Yes	Ramp Slope (%)	7.9
No	Ramp Width (in)	40.0	No	Ramp XSlope (%)	5.8
N/A	Flare Type LT	N/A	N/A	Flare Type RT	N/A
N/A	Flare Slope LT (%)	N/A	N/A	Flare Slope RT (%)	N/A
N/A	Flare Traversable LT?	N/A	N/A	Flare Traversable RT?	N/A
N/A	Landing Length (in)	N/A	N/A	DWS Provided?	N/A
N/A	Landing Width (in)	N/A	N/A	DWS Contrast?	N/A
N/A	Landing Slope (%)	N/A	N/A	DWS Length (in)	N/A
N/A	Landing X Slope (%)	N/A	N/A	DWS Full Width?	N/A
N/A	Landing Curb? (Y/N)	N/A	N/A	DWS Offset (in)	N/A
N/A	Shared Landing?	N/A			
N/A	Gutter Ponding?	N/A	N/A	Gutter Slope (%)	N/A
N/A	Gutter Lip Ht (in)	N/A	N/A	Gutter X Slope (%)	N/A
N/A	Painted X Walk1?	No	N/A	Painted X Walk2?	No
	X Walk 1 Direction	To W		X Walk 2 Direction	To S
N/A	X Walk 1 Width (in)	N/A	N/A	X Walk 2 Width (in)	N/A
	X Walk 1 Slope (%)	5.9		X Walk 2 Slope (%)	0.3
	X Walk 1 X Slope (%)	2.8		X Walk 2 X Slope (%)	3.7

N/A	Ramp inside XWalk1?	N/A	N/A	Ramp inside XWalk2?	N/A
	Road Slope (%)	3.0	N/A	Clear Space?	N/A
	Road X Slope (%)	1.7	N/A	Clear Space to XWalk (in)	N/A
N/A	Any Obstructions?	N/A	N/A	Storm Grate/Utility Hazard?	N/A
	Obstruction Type			Storm Grate/Utility Type	
		N/A			N/A
			Yes	Surface Condition? (G/P)	Good

Remove & Replace Curb Ramp With Two New Directional Ramps or Equivalent.
