Access Compliance Report

Public Rights-of-Way (Curb Ramps)

Intersection ID: 52915	Main Street: WILLOW_GREEN_PL	Cross Street: WOODWARD_AV	Location: S
ADA ID: 5925D0412825	Ramp Type: Directional1	Initial Pass/Fail: Fail	Overall Compliance: No
		Severity Score: 12.5

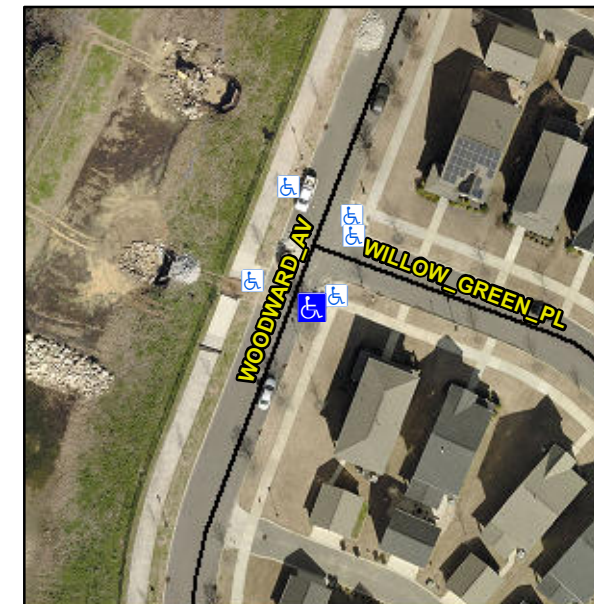
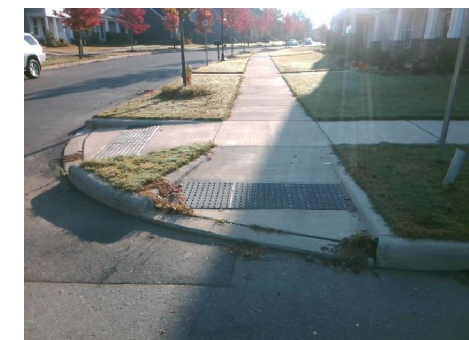
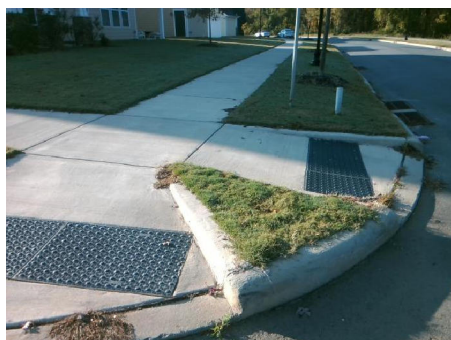
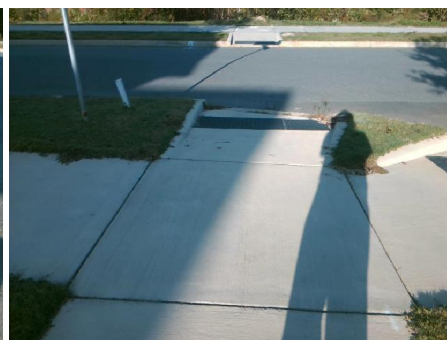
R304.2.2

Compliance	Description	Data	Compliance	Description	Data
N/A	Ramp Length (in)	77.0	N/A	Grade Break?	N/A
Yes	Ramp Width (in)	63.0	N/A	Grade Break Slope (%)	0.0
No	Ramp Slope (%)	8.8	N/A	Grade Break XSlope (%)	0.0
Yes	Ramp XSlope (%)	1.5			
N/A	Flare Type LT	N/A	N/A	Flare Type RT	N/A
N/A	Flare Slope LT (%)	N/A	N/A	Flare Slope RT (%)	0.0
N/A	Flare Traversable LT?	N/A	N/A	Flare Traversable RT?	N/A
N/A	Landing Length (in)	0.0	N/A	DWS Provided?	N/A
N/A	Landing Width (in)	0.0	N/A	DWS Contrast?	N/A
N/A	Landing Slope (%)	0.0	N/A	DWS Length (in)	N/A
N/A	Landing X Slope (%)	0.0	N/A	DWS Full Width?	N/A
N/A	Landing Curb? (Y/N)	N/A	N/A	DWS Offset LT (in)	N/A
N/A	Shared Landing?	N/A	N/A	DWS Offset RT (in)	N/A
N/A	Gutter Ponding?	0.0	N/A	Gutter Slope (%)	N/A
N/A	Gutter Lip Ht (in)	0.0	N/A	Gutter X Slope (%)	N/A
N/A	Painted X Walk1?	No		Road Slope (%)	3.7
	X Walk 1 Direction	To W		Road X Slope (%)	1.0
	X Walk 1 Width (in)	N/A		Clear Space?	N/A

X Walk 1 Slope (%)	3.7	N/A	Clear Space to XWalk (in)	N/A
	X Walk 1 X Slope (%)	1.0	N/A	Storm Grate/Utility Hazard?	N/A
N/A	Ramp inside XWalk1?	N/A		Storm Grate/Utility Type	
N/A	Any Obstructions?	N/A			N/A
	Obstruction Type		Yes	Surface Condition? (G/P)	Good
			N/A	Curb Slope (%)	3.1

Remove & Replace Entire Ramp.
