# Access Compliance Report

## Public Rights-of-Way

### (Curb Ramps)

Intersection ID: 20185	Main Street: FAIRVIEW_RD	Cross Street: PIEDMONT_ROW_DR	Location: NE
ADA ID: 59279713E568	Ramp Type: Perp	Initial Pass/Fail: Fail	Overall Compliance: No
Severity Score: 12.5			
Codes/Mitigation Info/Possible Solution		Field Measurements/Component Compliance

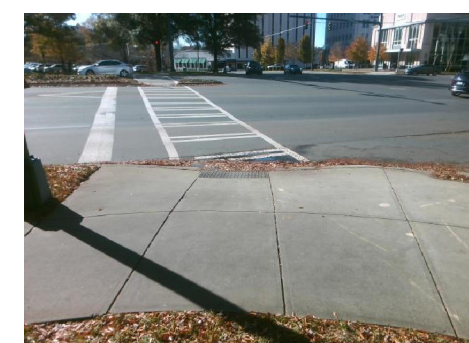
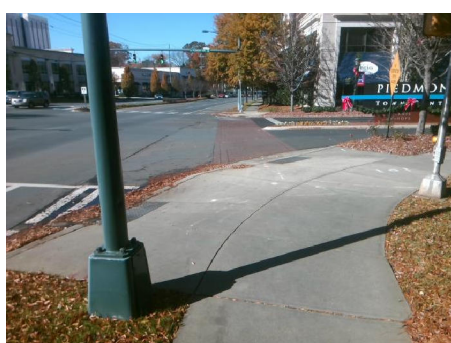
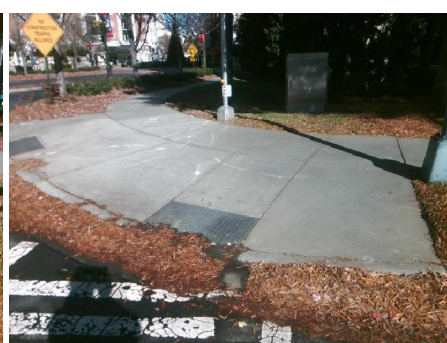
Compliance	Description	Data	Compliance	Description	Data
N/A	Ramp Length (in)	96.0	No	Ramp Slope (%)	11.0
Yes	Ramp Width (in)	48.0	Yes	Ramp XSlope (%)	2.0
N/A	Flare Type LT	N/A	N/A	Flare Type RT	N/A
N/A	Flare Slope LT (%)	N/A	N/A	Flare Slope RT (%)	N/A
N/A	Flare Traversable LT?	N/A	N/A	Flare Traversable RT?	N/A
N/A	Landing Length (in)	N/A	N/A	DWS Provided?	N/A
N/A	Landing Width (in)	N/A	N/A	DWS Contrast?	N/A
N/A	Landing Slope (%)	N/A	N/A	DWS Length (in)	N/A
N/A	Landing X Slope (%)	N/A	N/A	DWS Full Width?	N/A
N/A	Landing Curb? (Y/N)	N/A	N/A	DWS Offset (in)	N/A
N/A	Shared Landing?	N/A			
N/A	Gutter Ponding?	N/A	N/A	Gutter Slope (%)	N/A
N/A	Gutter Lip Ht (in)	N/A	N/A	Gutter X Slope (%)	N/A
N/A	Painted X Walk1?	Yes	N/A	Painted X Walk2?	N/A
	X Walk 1 Direction	To SW		X Walk 2 Direction	N/A
N/A	X Walk 1 Width (in)	93.0	N/A	X Walk 2 Width (in)	N/A
	X Walk 1 Slope (%)	3.6		X Walk 2 Slope (%)	N/A
	X Walk 1 X Slope (%)	1.6		X Walk 2 X Slope (%)	N/A

N/A	Ramp inside XWalk1?	Yes	N/A	Ramp inside XWalk2?	N/A
	Road Slope (%)	N/A	N/A	Clear Space?	N/A
	Road X Slope (%)	N/A	N/A	Clear Space to XWalk (in)	N/A
N/A	Any Obstructions?	N/A	N/A	Storm Grate/Utility Hazard?	N/A
	Obstruction Type			Storm Grate/Utility Type	
		N/A			N/A
		Yes		Surface Condition? (G/P)	Good

Possible Solutions:

**Remove & Replace Entire Ramp.**

**R304.2.2**
