Access Compliance Report Public Rights-of-Way (Curb Ramps)

Intersection ID: 12205 Main Street: S_MINT_ST Cross Street: W_3RD_ST Location: N

ADA ID: 592F681AF576 Ramp Type: Perp Initial Pass/Fail: Fail Overall Compliance: No Severity Score: 21.25

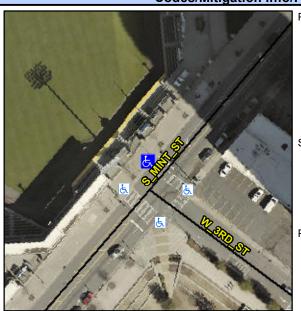
<u>u33/1 (</u>	ani. I an Overan	Compilar	CC. IN	o deventy ocore.	21.20	
Field Measurements/Component Compliance						
Compliance Description		Data	Compliance Description		Data	
N/A	Ramp Length (in)	78.0	No	Ramp Slope (%)	11.3	
No	Ramp Width (in)	47.5	Yes	Ramp XSlope (%)	0.6	
N/A	Flare Type LT	N/A	N/A	Flare Type RT	N/A	
N/A	Flare Slope LT (%)	N/A	N/A	Flare Slope RT (%)	N/A	
N/A	Flare Traversable LT?	N/A	N/A	Flare Traversable RT?	N/A	
N/A	Landing Length (in)	N/A	N/A	DWS Provided?	N/A	
N/A	Landing Width (in)	N/A	N/A	DWS Contrast?	N/A	
N/A	Landing Slope (%)	N/A	N/A	DWS Length (in)	N/A	
N/A	Landing X Slope (%)	N/A	N/A	DWS Full Width?	N/A	
N/A	Landing Curb? (Y/N)	N/A	N/A	DWS Offset (in)	N/A	
N/A	Shared Landing?	N/A				
N/A	Gutter Ponding?	N/A	N/A	Gutter Slope (%)	N/A	
N/A	Gutter Lip Ht (in)	N/A	N/A	Gutter X Slope (%)	N/A	
N/A	Painted X Walk1?	Yes	N/A	Painted X Walk2?	N/A	
	X Walk 1 Direction	To SE		X Walk 2 Direction	N/A

N/A	X Walk 1 Width (in)	113.0	N/A	X Walk 2 Width (in)	N/A	
	X Walk 1 Slope (%)	0.6		X Walk 2 Slope (%)	N/A	
	X Walk 1 X Slope (%)	0.7		X Walk 2 X Slope (%)	N/A	
N/A	Ramp inside XWalk1?	Yes	N/A	Ramp inside XWalk2?	N/A	
	Road Slope (%)	N/A	N/A	Clear Space?	N/A	
	Road X Slope (%)	N/A	N/A	Clear Space to XWalk (in)	N/A	
N/A	Any Obstructions?	N/A	N/A	Storm Grate/Utility Hazard?	N/A	
	Obstruction Type			Storm Grate/Utility Type		
		N/A			N/A	
			Yes	Surface Condition? (G/P)	Good

1 CCCIDIC CCIALICII					
Possible Solutions:					
Remove & Replace Entire Ramp.					
Surveyor Notes:					
N/A					
PROW/ADA:					
Not Found, R304.5.1, R304.2.2
