Access Compliance Report

Public Rights-of-Way

(Curb Ramps)

Intersection ID: 10039485	Main Street: TELEVISION_PL	Cross Street: N/A	Location: NW
ADA ID: 593438C564CE	Ramp Type: PerpDiag	Initial Pass/Fail: Fail	Overall Compliance: No
Severity Score: 22.5			
Codes/Mitigation Info/Possible Solution		Field Measurements/Component Compliance

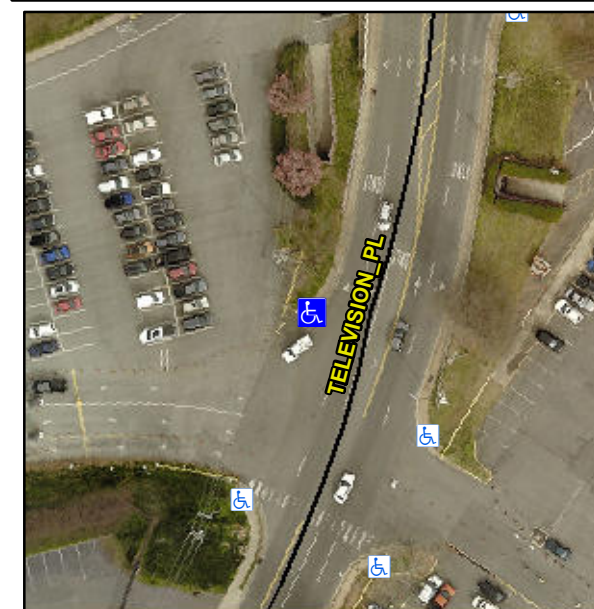
Not Found, R304.5.1, R304.2.2, R304.5.3

Compliance	Description	Data	Compliance	Description	Data
N/A	Ramp Length (in)	48.0	No	Ramp Slope (%)	10.9
No	Ramp Width (in)	38.0	No	Ramp XSlope (%)	2.2
N/A	Flare Type LT	N/A	N/A	Flare Type RT	N/A
N/A	Flare Slope LT (%)	N/A	N/A	Flare Slope RT (%)	N/A
N/A	Flare Traversable LT?	N/A	N/A	Flare Traversable RT?	N/A
N/A	Landing Length (in)	N/A	N/A	DWS Provided?	N/A
N/A	Landing Width (in)	N/A	N/A	DWS Contrast?	N/A
N/A	Landing Slope (%)	N/A	N/A	DWS Length (in)	N/A
N/A	Landing X Slope (%)	N/A	N/A	DWS Full Width?	N/A
N/A	Landing Curb? (Y/N)	N/A	N/A	DWS Offset (in)	N/A
N/A	Shared Landing?	N/A			
N/A	Gutter Ponding?	N/A	N/A	Gutter Slope (%)	N/A
N/A	Gutter Lip Ht (in)	N/A	N/A	Gutter X Slope (%)	N/A
N/A	Painted X Walk1?	No	N/A	Painted X Walk2?	No
	X Walk 1 Direction	To SW		X Walk 2 Direction	To SE
N/A	X Walk 1 Width (in)	N/A	N/A	X Walk 2 Width (in)	N/A
	X Walk 1 Slope (%)	7.4		X Walk 2 Slope (%)	6.9
	X Walk 1 X Slope (%)	3.8		X Walk 2 X Slope (%)	5.2

N/A	Ramp inside XWalk1?	N/A	N/A	Ramp inside XWalk2?	N/A
	Road Slope (%)	0.9	N/A	Clear Space?	N/A
	Road X Slope (%)	7.7	N/A	Clear Space to XWalk (in)	N/A
N/A	Any Obstructions?	N/A	N/A	Storm Grate/Utility Hazard?	N/A
	Obstruction Type			Storm Grate/Utility Type	
		N/A			N/A
			Yes	Surface Condition? (G/P)	Good

Possible Solutions:

Remove & Replace Curb Ramp With Two New Directional Ramps or Equivalent.
