# Access Compliance Report

## Public Rights-of-Way

### (Curb Ramps)

| Intersection ID: 14812 | Main Street: KENMORE_AV | Cross Street: N_DOTGER_AV | Location: W |

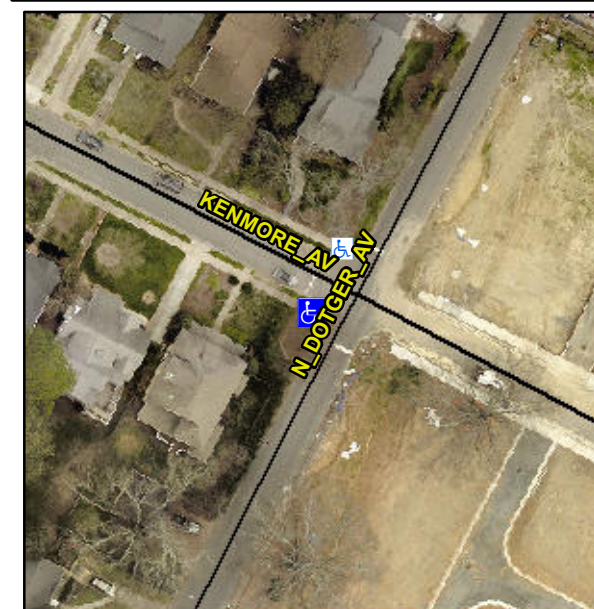
| ADA ID: 593638733073 | Ramp Type: PerpDiag | Initial Pass/Fail: Fail | Overall Compliance: No |
| Severity Score: 13.75 | | | |

**R304.2.2, R304.5.3**

| Compliance | Description | Data | Compliance | Description | Data |
|---|---|---|---|---|---|
| N/A | Ramp Length (in) | 26.0 | No | Ramp Slope (%) | 8.4 |
| Yes | Ramp Width (in) | 48.0 | No | Ramp XSlope (%) | 4.2 |

**Remove & Replace Curb Ramp With Two New Directional Ramps or Equivalent.**

Total Cost: \$ 3200.00
