## **Access Compliance Report Public Rights-of-Way** (Curb Ramps)

Intersection ID: 50932 Main Street: SCHOLASTIC DR Cross Street: CLEMS\_BRANCH\_DR Location: S **Severity Score:** ADA ID: 593D1F5A7D44 Ramp Type: Perp Initial Pass/Fail: Fail **Overall Compliance: No** 22.5

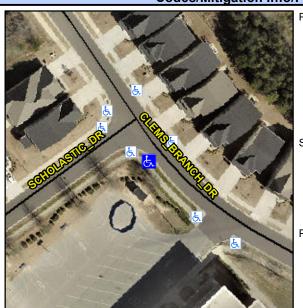
Field Measurements/Component Compliance						
Compliance Description Date		Data	Comp	liance Description	Data	
N/A	Ramp Length (in)	46.0	No	Ramp Slope (%)	9.4	
No	Ramp Width (in)	47.0	No	Ramp XSlope (%)	4.3	
N/A	Flare Type LT	N/A	N/A	Flare Type RT	N/A	
N/A	Flare Slope LT (%)	N/A	N/A	Flare Slope RT (%)	N/A	
N/A	Flare Traversable LT?	N/A	N/A	Flare Traversable RT?	N/A	
N/A	Landing Length (in)	N/A	N/A	DWS Provided?	N/A	
N/A	Landing Width (in)	N/A	N/A	DWS Contrast?	N/A	
N/A	Landing Slope (%)	N/A	N/A	DWS Length (in)	N/A	
N/A	Landing X Slope (%)	N/A	N/A	DWS Full Width?	N/A	
N/A	Landing Curb? (Y/N)	N/A	N/A	DWS Offset (in)	N/A	
N/A	Shared Landing?	N/A				
N/A	Gutter Ponding?	N/A	N/A	Gutter Slope (%)	N/A	
N/A	Gutter Lip Ht (in)	N/A	N/A	Gutter X Slope (%)	N/A	
N/A	Painted X Walk1?	No	N/A	Painted X Walk2?	N/A	
	X Walk 1 Direction	To NE		X Walk 2 Direction	N/A	
N/A	X Walk 1 Width (in)	N/A	N/A	X Walk 2 Width (in)	N/A	
	X Walk 1 Slope (%)	3.2		X Walk 2 Slope (%)	N/A

X Walk 1 X Slope (%)	4.1		X Walk 2 X Slope (%)	N/A	
N/A	Ramp inside XWalk1?	N/A	N/A	Ramp inside XWalk2?	N/A	
	Road Slope (%)	N/A	N/A	Clear Space?	N/A	
	Road X Slope (%)	N/A	N/A	Clear Space to XWalk (in)	N/A	
N/A	Any Obstructions?	N/A	N/A	Storm Grate/Utility Hazard?	N/A	
	Obstruction Type			Storm Grate/Utility Type		
		N/A			N/A	
			Yes	Surface Condition? (G/P)	Good	
ingli	H (1) 10 0 0 0

Possible Solutions: Remove & Replace Entire Ramp. Surveyor Notes: N/A PROW/ADA: Not Found, R304.5.1, R304.2.2, R304.5.3
