Access Compliance Report

Public Rights-of-Way

(Curb Ramps)

Intersection ID: 13960	Main Street: CENTRAL_AV	Cross Street: KILBORNE_DR	Location: NE
ADA ID: 593E67CCCC1D	Ramp Type: Para	Initial Pass/Fail: Pass	Overall Compliance: No
Severity Score: 0.25			
Codes/Mitigation Info/Possible Solution		Field Measurements/Component Compliance

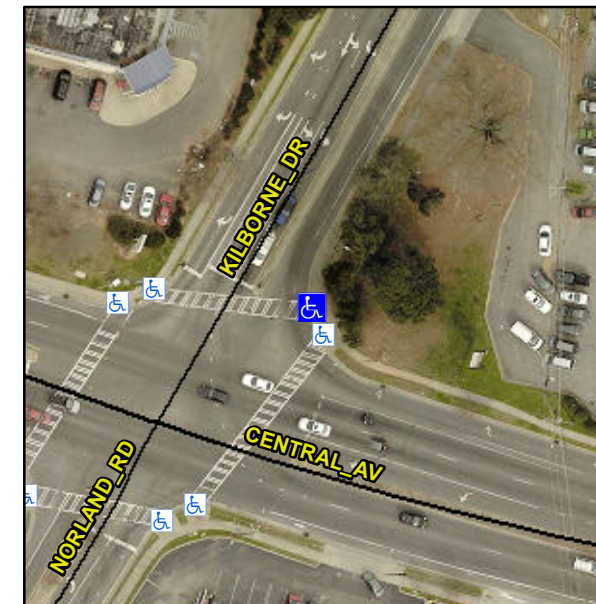
RT RP < 5%

**Not Found, R304.5.3, R304.2.1,
R304.2.2-Perp, R304.3.2-Para**

Compliance	Description	Data	Compliance	Description	Data
N/A	Ramp Length LT (in)	55.0	N/A	Ramp Length RT (in)	56.0
Yes	Ramp Width LT (in)	59.5	Yes	Ramp Width RT (in)	60.0
Yes	Ramp Slope LT (%)	6.1	Yes	Ramp Slope RT (%)	2.3
Yes	Ramp XSlope LT (%)	1.7	No	Ramp XSlope RT (%)	2.3
Yes	Landing Length (in)	60.0	Yes	DWS Provided?	Yes
No	Landing Width (in)	32.0	Yes	DWS Contrast?	Yes
No	Landing Slope (%)	2.8	Yes	DWS Length (in)	24.0
Yes	Landing X Slope (%)	1.4	Yes	DWS Full Width?	Yes
N/A	Landing Curb? (Y/N)	No	Yes	DWS Offset (in)	2.0
N/A	Shared Landing?	No			
Yes	Gutter Ponding?	No	Yes	Gutter Slope (%)	3.2
Yes	Gutter Lip Ht (in)	0.0	Yes	Gutter X Slope (%)	1.8
N/A	Painted X Walk1?	Yes	N/A	Painted X Walk2?	N/A
	X Walk 1 Direction	To W		X Walk 2 Direction	N/A
N/A	X Walk 1 Width (in)	109.0	N/A	X Walk 2 Width (in)	N/A
	X Walk 1 Slope (%)	3.8		X Walk 2 Slope (%)	N/A
	X Walk 1 X Slope (%)	3.0		X Walk 2 X Slope (%)	N/A
Yes	Ramp inside XWalk1?	Yes	N/A	Ramp inside XWalk2?	N/A

Road Slope (%)	N/A	N/A	Clear Space?	Yes
	Road X Slope (%)	N/A	N/A	Clear Space to XWalk (in)	N/A
Yes	Any Obstructions?	No	Yes	Storm Grate/Utility Hazard?	No
	Obstruction Type			Storm Grate/Utility Type	
		N/A			N/A
			Yes	Surface Condition? (G/P)	Good
			Replace	Curb Slope (%)	19.4

Possible Solutions:

Remove & Replace Entire Ramp.
