# Access Compliance Report

## Public Rights-of-Way

### (Curb Ramps)

| Intersection ID: 12472 | Main Street: MONUMENT_ST | Cross Street: ARTY_AV | Location: SE |

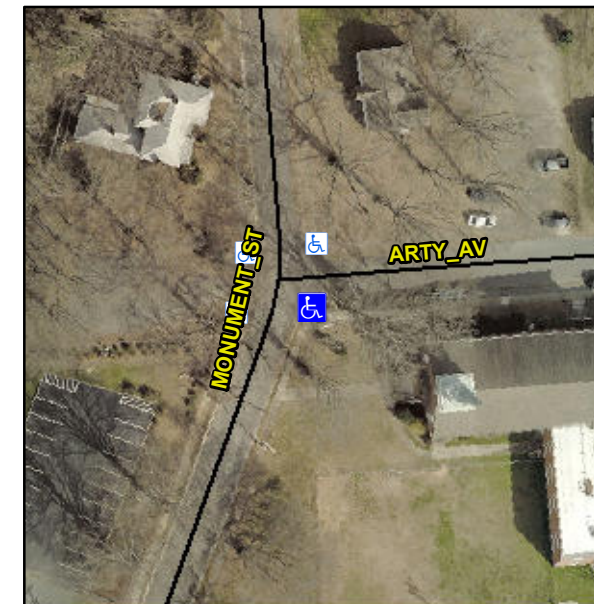
| ADA ID: 59440AAAECAA | Ramp Type: PerpDiag | Initial Pass/Fail: Fail | Overall Compliance: No |

**Not Found, R304.5.1, R304.5.3**

| Compliance | Description | Data | Compliance | Description | Data |
|---|---|---|---|---|---|
| N/A | Ramp Length (in) | 93.5 | Yes | Ramp Slope (%) | 5.7 |
| No | Ramp Width (in) | 47.0 | No | Ramp XSlope (%) | 2.4 |

**Remove & Replace Curb Ramp With Two New Directional Ramps or Equivalent.**
