Access Compliance Report

Public Rights-of-Way

(Curb Ramps)

Intersection ID: 2454	Main Street: CLARKE_CREEK_PY	Cross Street: MILLSTREAM_RIDGE_DR	Location: NW
ADA ID: 595450593DCC	Ramp Type: ParaDiag	Initial Pass/Fail: Fail	Overall Compliance: No
		Severity Score: 35

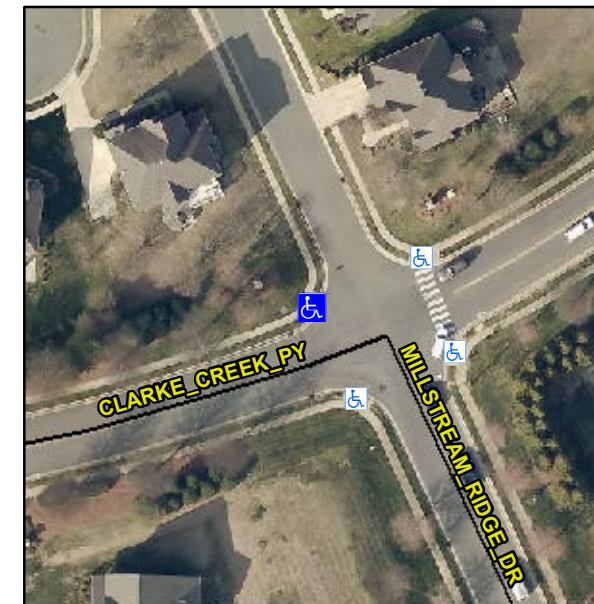
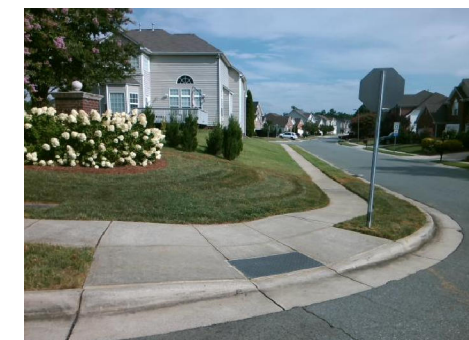
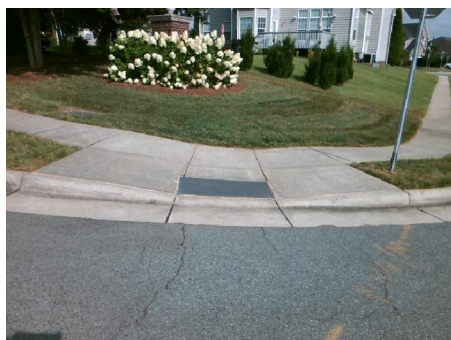
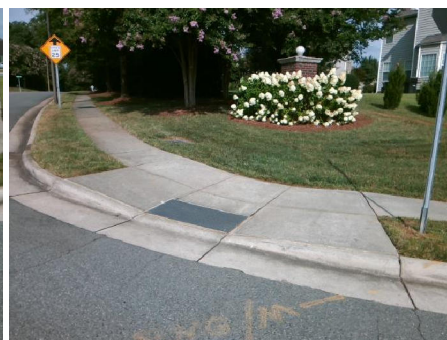
RT RP < 5%

Compliance	Description	Data	Compliance	Description	Data
N/A	Ramp Length LT (in)	52.0	N/A	Ramp Length RT (in)	48.0
No	Ramp Width LT (in)	42.0	No	Ramp Width RT (in)	46.0
No	Ramp Slope LT (%)	16.1	Yes	Ramp Slope RT (%)	0.8
No	Ramp XSlope LT (%)	3.2	Yes	Ramp XSlope RT (%)	2.0
N/A	Landing Length (in)	N/A	N/A	DWS Provided?	N/A
N/A	Landing Width (in)	N/A	N/A	DWS Contrast?	N/A
N/A	Landing Slope (%)	N/A	N/A	DWS Length (in)	N/A
N/A	Landing X Slope (%)	N/A	N/A	DWS Full Width?	N/A
N/A	Landing Curb? (Y/N)	N/A	N/A	DWS Offset (in)	N/A
N/A	Shared Landing?	N/A			
N/A	Gutter Ponding?	N/A	N/A	Gutter Slope (%)	N/A
N/A	Gutter Lip Ht (in)	N/A	N/A	Gutter X Slope (%)	N/A
N/A	Painted X Walk1?	No	N/A	Painted X Walk2?	No
	X Walk 1 Direction	To S		X Walk 2 Direction	To E
N/A	X Walk 1 Width (in)	N/A	N/A	X Walk 2 Width (in)	N/A
	X Walk 1 Slope (%)	4.7		X Walk 2 Slope (%)	5.3
	X Walk 1 X Slope (%)	3.3		X Walk 2 X Slope (%)	3.6
N/A	Ramp inside XWalk1?	N/A	N/A	Ramp inside XWalk2?	N/A

Road Slope (%)	6.4	N/A	Clear Space?	N/A
	Road X Slope (%)	0.7	N/A	Clear Space to XWalk (in)	N/A
N/A	Any Obstructions?	N/A	N/A	Storm Grate/Utility Hazard?	N/A
	Obstruction Type			Storm Grate/Utility Type	
		N/A			N/A
			Yes	Surface Condition? (G/P)	Good
			N/A	Curb Slope (%)	18.7

Remove & Replace Curb Ramp With Two New Directional Ramps or Equivalent.
