# Access Compliance Report

## Public Rights-of-Way

### (Curb Ramps)

Intersection ID: N/A	Main Street: SOUTHGROVE_ST	Cross Street: WAVERLY_CENTER_DR	Location: NE
ADA ID: 5964F73FB0CE	Ramp Type: Perp	Initial Pass/Fail: Fail	Overall Compliance: No
		Severity Score: 12.5

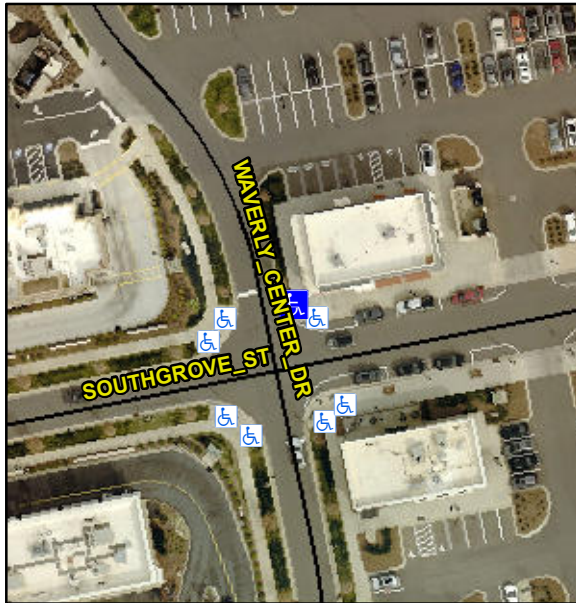
**Not Found, R304.2.2**

Compliance	Description	Data	Compliance	Description	Data
N/A	Ramp Length (in)	62.0	No	Ramp Slope (%)	10.6
Yes	Ramp Width (in)	48.0	Yes	Ramp XSlope (%)	0.1
N/A	Flare Type LT	N/A	N/A	Flare Type RT	N/A
N/A	Flare Slope LT (%)	N/A	N/A	Flare Slope RT (%)	N/A
N/A	Flare Traversable LT?	N/A	N/A	Flare Traversable RT?	N/A
N/A	Landing Length (in)	N/A	N/A	DWS Provided?	N/A
N/A	Landing Width (in)	N/A	N/A	DWS Contrast?	N/A
N/A	Landing Slope (%)	N/A	N/A	DWS Length (in)	N/A
N/A	Landing X Slope (%)	N/A	N/A	DWS Full Width?	N/A
N/A	Landing Curb? (Y/N)	N/A	N/A	DWS Offset (in)	N/A
N/A	Shared Landing?	N/A			
N/A	Gutter Ponding?	N/A	N/A	Gutter Slope (%)	N/A
N/A	Gutter Lip Ht (in)	N/A	N/A	Gutter X Slope (%)	N/A
N/A	Painted X Walk1?	No	N/A	Painted X Walk2?	N/A
	X Walk 1 Direction	To W		X Walk 2 Direction	N/A
N/A	X Walk 1 Width (in)	N/A	N/A	X Walk 2 Width (in)	N/A
	X Walk 1 Slope (%)	1.3		X Walk 2 Slope (%)	N/A
	X Walk 1 X Slope (%)	0.4		X Walk 2 X Slope (%)	N/A

N/A	Ramp inside XWalk1?	N/A	N/A	Ramp inside XWalk2?	N/A
	Road Slope (%)	N/A	N/A	Clear Space?	N/A
	Road X Slope (%)	N/A	N/A	Clear Space to XWalk (in)	N/A
N/A	Any Obstructions?	N/A	N/A	Storm Grate/Utility Hazard?	N/A
	Obstruction Type			Storm Grate/Utility Type	
		N/A			N/A
			Yes	Surface Condition? (G/P)	Good

Possible Solutions:

**Remove & Replace Entire Ramp.**
