# Access Compliance Report

## Public Rights-of-Way

### (Curb Ramps)

Intersection ID: 5152	Main Street: MALLARD_CREEK_RD	Cross Street: BAUCOM_RD	Location: W
ADA ID: 5967BD5EAA8A	Ramp Type: Perp	Initial Pass/Fail: Fail	Overall Compliance: No
Severity Score: 21.25			
Codes/Mitigation Info/Possible Solution		Field Measurements/Component Compliance

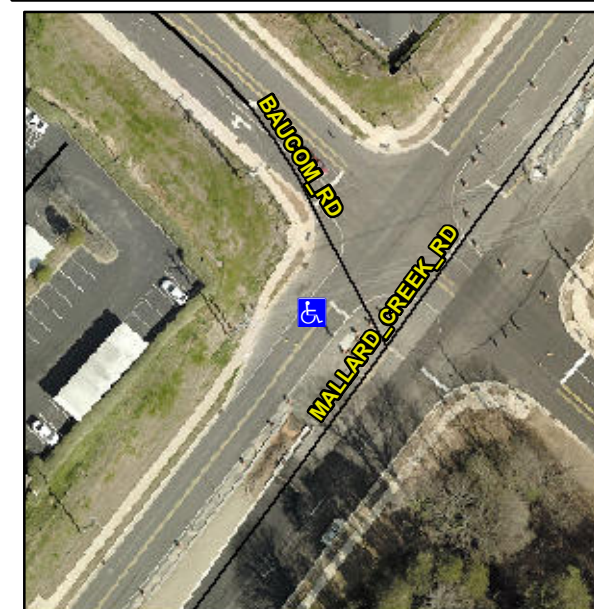
**Not Found, R304.5.1, R304.5.3**

Compliance	Description	Data	Compliance	Description	Data
N/A	Ramp Length (in)	224.0	Yes	Ramp Slope (%)	6.7
No	Ramp Width (in)	41.0	No	Ramp XSlope (%)	5.5
N/A	Flare Type LT	N/A	N/A	Flare Type RT	N/A
N/A	Flare Slope LT (%)	N/A	N/A	Flare Slope RT (%)	N/A
N/A	Flare Traversable LT?	N/A	N/A	Flare Traversable RT?	N/A
N/A	Landing Length (in)	N/A	N/A	DWS Provided?	N/A
N/A	Landing Width (in)	N/A	N/A	DWS Contrast?	N/A
N/A	Landing Slope (%)	N/A	N/A	DWS Length (in)	N/A
N/A	Landing X Slope (%)	N/A	N/A	DWS Full Width?	N/A
N/A	Landing Curb? (Y/N)	N/A	N/A	DWS Offset (in)	N/A
N/A	Shared Landing?	N/A			
N/A	Gutter Ponding?	N/A	N/A	Gutter Slope (%)	N/A
N/A	Gutter Lip Ht (in)	N/A	N/A	Gutter X Slope (%)	N/A
N/A	Painted X Walk1?	No	N/A	Painted X Walk2?	N/A
	X Walk 1 Direction	To NE		X Walk 2 Direction	N/A
N/A	X Walk 1 Width (in)	N/A	N/A	X Walk 2 Width (in)	N/A
	X Walk 1 Slope (%)	2.2		X Walk 2 Slope (%)	N/A
	X Walk 1 X Slope (%)	6.3		X Walk 2 X Slope (%)	N/A

N/A	Ramp inside XWalk1?	N/A	N/A	Ramp inside XWalk2?	N/A
	Road Slope (%)	N/A	N/A	Clear Space?	N/A
	Road X Slope (%)	N/A	N/A	Clear Space to XWalk (in)	N/A
N/A	Any Obstructions?	N/A	N/A	Storm Grate/Utility Hazard?	N/A
	Obstruction Type			Storm Grate/Utility Type	
		N/A			N/A
		Yes		Surface Condition? (G/P)	Good

Possible Solutions:

**Remove & Replace Entire Ramp.**
