Access Compliance Report

Public Rights-of-Way

(Curb Ramps)

Intersection ID: 19907	Main Street: SEDLEY_RD	Cross Street: FOXCROFT_RD	Location: NE
ADA ID: 5975D8DBB2C2	Ramp Type: PerpDiag	Initial Pass/Fail: Fail	Overall Compliance: No
		Severity Score: 12.5

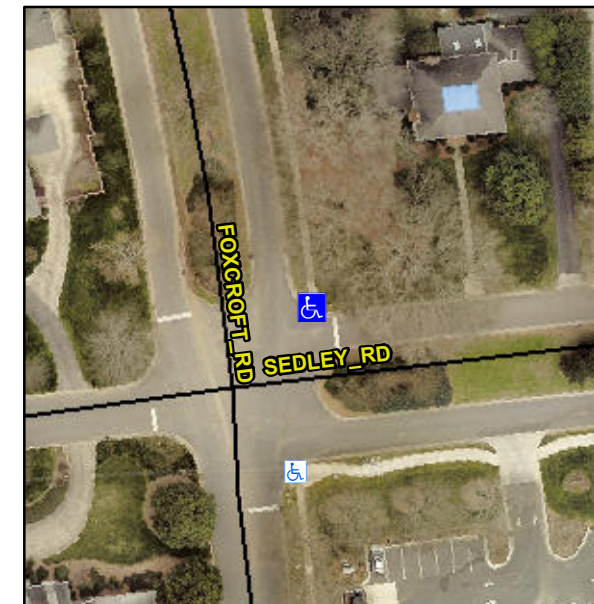
Not Found, R304.2.2

Compliance	Description	Data	Compliance	Description	Data
N/A	Ramp Length (in)	66.0	No	Ramp Slope (%)	11.2
Yes	Ramp Width (in)	48.0	Yes	Ramp XSlope (%)	0.1
N/A	Flare Type LT	N/A	N/A	Flare Type RT	N/A
N/A	Flare Slope LT (%)	N/A	N/A	Flare Slope RT (%)	N/A
N/A	Flare Traversable LT?	N/A	N/A	Flare Traversable RT?	N/A
N/A	Landing Length (in)	N/A	N/A	DWS Provided?	N/A
N/A	Landing Width (in)	N/A	N/A	DWS Contrast?	N/A
N/A	Landing Slope (%)	N/A	N/A	DWS Length (in)	N/A
N/A	Landing X Slope (%)	N/A	N/A	DWS Full Width?	N/A
N/A	Landing Curb? (Y/N)	N/A	N/A	DWS Offset (in)	N/A
N/A	Shared Landing?	N/A			
N/A	Gutter Ponding?	N/A	N/A	Gutter Slope (%)	N/A
N/A	Gutter Lip Ht (in)	N/A	N/A	Gutter X Slope (%)	N/A
N/A	Painted X Walk1?	No	N/A	Painted X Walk2?	No
	X Walk 1 Direction	To W		X Walk 2 Direction	To S
N/A	X Walk 1 Width (in)	N/A	N/A	X Walk 2 Width (in)	N/A
	X Walk 1 Slope (%)	5.5		X Walk 2 Slope (%)	4.9
	X Walk 1 X Slope (%)	3.1		X Walk 2 X Slope (%)	2.6

N/A	Ramp inside XWalk1?	N/A	N/A	Ramp inside XWalk2?	N/A
	Road Slope (%)	1.1	N/A	Clear Space?	N/A
	Road X Slope (%)	6.3	N/A	Clear Space to XWalk (in)	N/A
N/A	Any Obstructions?	N/A	N/A	Storm Grate/Utility Hazard?	N/A
	Obstruction Type			Storm Grate/Utility Type	
		N/A			N/A
			Yes	Surface Condition? (G/P)	Good

Remove & Replace Curb Ramp With Two New Directional Ramps or Equivalent.
