# Access Compliance Report

## Public Rights-of-Way

### (Curb Ramps)

Intersection ID: 3901	Main Street: RHIAN_BROOK_LN	Cross Street: BEATTIES_FORD_RD	Location: SE
ADA ID: 5985A7BFBD9E	Ramp Type: Perp	Initial Pass/Fail: Fail	Overall Compliance: No
		Severity Score: 12.5

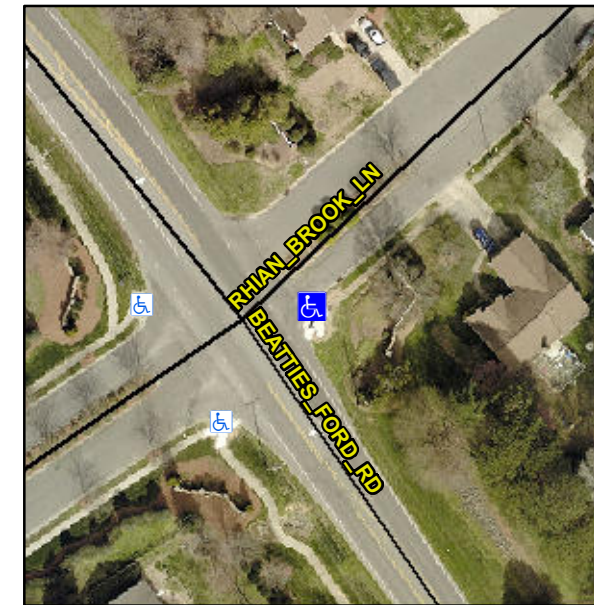
**Not Found, R304.2.2**

Compliance	Description	Data	Compliance	Description	Data
N/A	Ramp Length (in)	93.0	No	Ramp Slope (%)	11.1
Yes	Ramp Width (in)	48.0	Yes	Ramp XSlope (%)	1.4
N/A	Flare Type LT	N/A	N/A	Flare Type RT	N/A
N/A	Flare Slope LT (%)	N/A	N/A	Flare Slope RT (%)	N/A
N/A	Flare Traversable LT?	N/A	N/A	Flare Traversable RT?	N/A
N/A	Landing Length (in)	N/A	N/A	DWS Provided?	N/A
N/A	Landing Width (in)	N/A	N/A	DWS Contrast?	N/A
N/A	Landing Slope (%)	N/A	N/A	DWS Length (in)	N/A
N/A	Landing X Slope (%)	N/A	N/A	DWS Full Width?	N/A
N/A	Landing Curb? (Y/N)	N/A	N/A	DWS Offset (in)	N/A
N/A	Shared Landing?	N/A			
N/A	Gutter Ponding?	N/A	N/A	Gutter Slope (%)	N/A
N/A	Gutter Lip Ht (in)	N/A	N/A	Gutter X Slope (%)	N/A
N/A	Painted X Walk1?	No	N/A	Painted X Walk2?	N/A
	X Walk 1 Direction	To N		X Walk 2 Direction	N/A
N/A	X Walk 1 Width (in)	N/A	N/A	X Walk 2 Width (in)	N/A
	X Walk 1 Slope (%)	0.0		X Walk 2 Slope (%)	N/A
	X Walk 1 X Slope (%)	1.4		X Walk 2 X Slope (%)	N/A

N/A	Ramp inside XWalk1?	N/A	N/A	Ramp inside XWalk2?	N/A
	Road Slope (%)	1.4	N/A	Clear Space?	N/A
	Road X Slope (%)	0.0	N/A	Clear Space to XWalk (in)	N/A
N/A	Any Obstructions?	N/A	N/A	Storm Grate/Utility Hazard?	N/A
	Obstruction Type			Storm Grate/Utility Type	
		N/A			N/A
			Yes	Surface Condition? (G/P)	Good

**Remove & Replace Entire Ramp.**

Total Cost: \$ 1850.00
