Access Compliance Report

Public Rights-of-Way

(Curb Ramps)

Intersection ID: 3809	Main Street: MOUNTAIN_TRAIL_DR	Cross Street: MT_ISLE_HARBOR_DR	Location: SE
ADA ID: 5998CB515FB9	Ramp Type: Perp	Initial Pass/Fail: Fail	Overall Compliance: No
Severity Score: 10			
Codes/Mitigation Info/Possible Solution		Field Measurements/Component Compliance

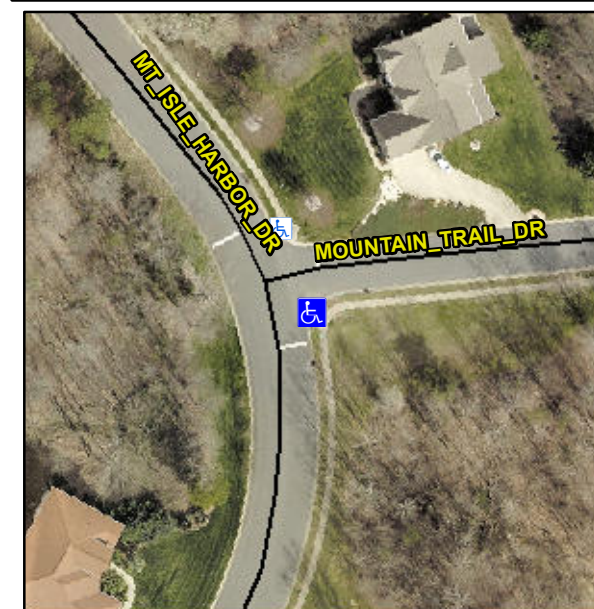
Compliance	Description	Data	Compliance	Description	Data
N/A	Ramp Length (in)	50.5	Yes	Ramp Slope (%)	5.6
No	Ramp Width (in)	47.5	No	Ramp XSlope (%)	2.1
N/A	Flare Type LT	N/A	N/A	Flare Type RT	N/A
N/A	Flare Slope LT (%)	N/A	N/A	Flare Slope RT (%)	N/A
N/A	Flare Traversable LT?	N/A	N/A	Flare Traversable RT?	N/A
N/A	Landing Length (in)	N/A	N/A	DWS Provided?	N/A
N/A	Landing Width (in)	N/A	N/A	DWS Contrast?	N/A
N/A	Landing Slope (%)	N/A	N/A	DWS Length (in)	N/A
N/A	Landing X Slope (%)	N/A	N/A	DWS Full Width?	N/A
N/A	Landing Curb? (Y/N)	N/A	N/A	DWS Offset (in)	N/A
N/A	Shared Landing?	N/A			
N/A	Gutter Ponding?	N/A	N/A	Gutter Slope (%)	N/A
N/A	Gutter Lip Ht (in)	N/A	N/A	Gutter X Slope (%)	N/A
N/A	Painted X Walk1?	No	N/A	Painted X Walk2?	N/A
	X Walk 1 Direction	To N		X Walk 2 Direction	N/A
N/A	X Walk 1 Width (in)	N/A	N/A	X Walk 2 Width (in)	N/A
	X Walk 1 Slope (%)	2.4		X Walk 2 Slope (%)	N/A
	X Walk 1 X Slope (%)	0.2		X Walk 2 X Slope (%)	N/A

N/A	Ramp inside XWalk1?	N/A	N/A	Ramp inside XWalk2?	N/A
	Road Slope (%)	N/A	N/A	Clear Space?	N/A
	Road X Slope (%)	N/A	N/A	Clear Space to XWalk (in)	N/A
N/A	Any Obstructions?	N/A	N/A	Storm Grate/Utility Hazard?	N/A
	Obstruction Type			Storm Grate/Utility Type	
		N/A			N/A
		Yes		Surface Condition? (G/P)	Good

Possible Solutions:

Remove & Replace Entire Ramp.

R304.5.1, R304.5.3
