# Access Compliance Report

## Public Rights-of-Way

### (Curb Ramps)

| Intersection ID: 50240 | Main Street: LONGSTONE_LN | Cross Street: CEDAR_WALK_LN | Location: NE |

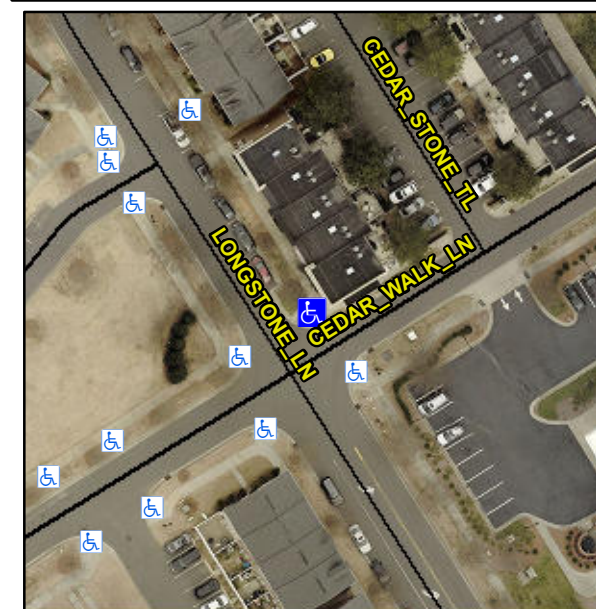
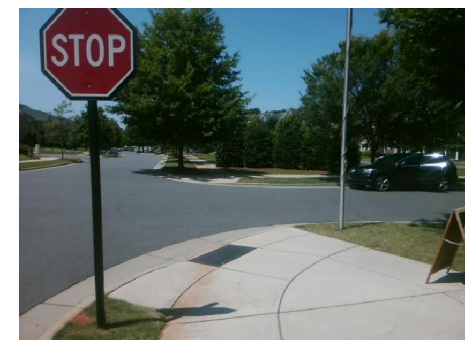
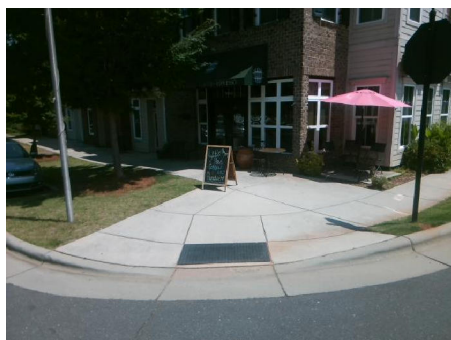
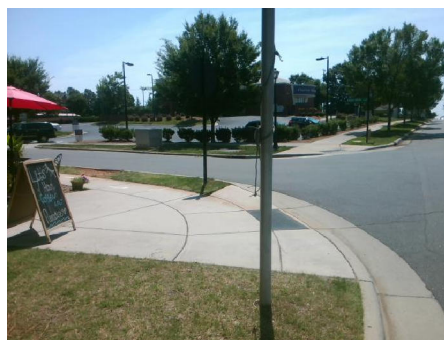
| ADA ID: 59A6824B2E35 | Ramp Type: BlendTrans2 | Initial Pass/Fail: Pass | Overall Compliance: No |
| Severity Score: 0.25 | | | |

**R304.5.3, R305.2**

| Compliance | Description | Data | Compliance | Description | Data |
|---|---|---|---|---|---|
| Yes | Ramp Width (in) | 48.0 | No | BlendTrans XSlope (%) | 2.6 |
| N/A | Landing Curb? (Y/N) | No | No | DWS Offset (in) | 4.0 |
| Yes | Gutter Lip Ht (in) | 0.0 | No | Gutter X Slope (%) | 3.8 |

**Remove & Replace Curb Ramp With Two New Directional Ramps or Equivalent. Remove & Replace Gutter.**
