Access Compliance Report

Public Rights-of-Way

(Curb Ramps)

Intersection ID: 50609	Main Street: DOWNY_BIRCH_RD	Cross Street: PADDLE_OAK_RD	Location: SE
ADA ID: 59A9FE7C7CAC	Ramp Type: Perp	Initial Pass/Fail: Fail	Overall Compliance: No
Severity Score: 1.25			
Codes/Mitigation Info/Possible Solution		Field Measurements/Component Compliance

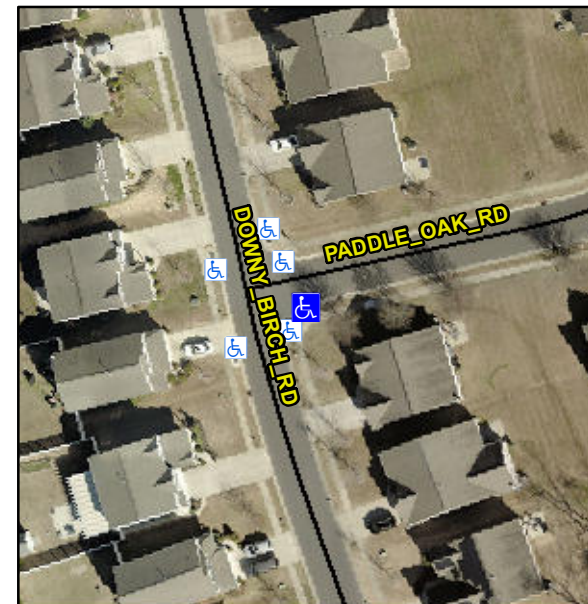
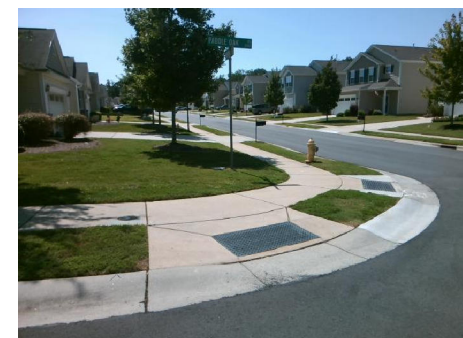
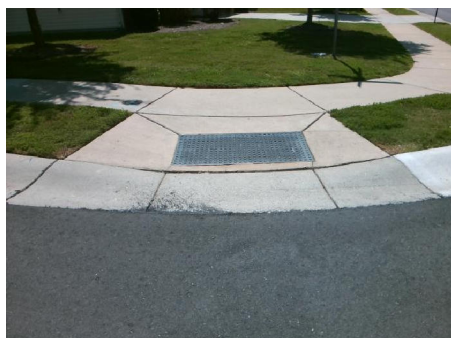
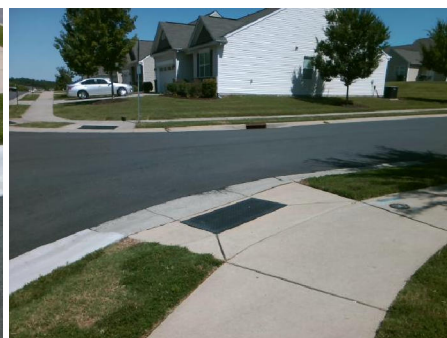
Not Found, R304.5.3

Compliance	Description	Data	Compliance	Description	Data
N/A	Ramp Length (in)	46.0	Yes	Ramp Slope (%)	8.0
Yes	Ramp Width (in)	48.0	No	Ramp XSlope (%)	4.0
N/A	Flare Type LT	N/A	N/A	Flare Type RT	N/A
N/A	Flare Slope LT (%)	N/A	N/A	Flare Slope RT (%)	N/A
N/A	Flare Traversable LT?	N/A	N/A	Flare Traversable RT?	N/A
N/A	Landing Length (in)	N/A	N/A	DWS Provided?	N/A
N/A	Landing Width (in)	N/A	N/A	DWS Contrast?	N/A
N/A	Landing Slope (%)	N/A	N/A	DWS Length (in)	N/A
N/A	Landing X Slope (%)	N/A	N/A	DWS Full Width?	N/A
N/A	Landing Curb? (Y/N)	N/A	N/A	DWS Offset (in)	N/A
N/A	Shared Landing?	N/A			
N/A	Gutter Ponding?	N/A	N/A	Gutter Slope (%)	N/A
N/A	Gutter Lip Ht (in)	N/A	N/A	Gutter X Slope (%)	N/A
N/A	Painted X Walk1?	No	N/A	Painted X Walk2?	N/A
	X Walk 1 Direction	To N		X Walk 2 Direction	N/A
N/A	X Walk 1 Width (in)	N/A	N/A	X Walk 2 Width (in)	N/A
	X Walk 1 Slope (%)	1.1		X Walk 2 Slope (%)	N/A
	X Walk 1 X Slope (%)	2.9		X Walk 2 X Slope (%)	N/A

N/A	Ramp inside XWalk1?	N/A	N/A	Ramp inside XWalk2?	N/A
	Road Slope (%)	N/A	N/A	Clear Space?	N/A
	Road X Slope (%)	N/A	N/A	Clear Space to XWalk (in)	N/A
N/A	Any Obstructions?	N/A	N/A	Storm Grate/Utility Hazard?	N/A
	Obstruction Type			Storm Grate/Utility Type	
		N/A			N/A
			Yes	Surface Condition? (G/P)	Good

Remove & Replace Entire Ramp.
