# Access Compliance Report

## Public Rights-of-Way

| Intersection ID: 13237 | Main Street: W_PARK_AV | Cross Street: WILMORE_DR | Location: NW |
| ADA ID: 59B371931FA1 | Ramp Type: PerpDiag | Initial Pass/Fail: Fail | Overall Compliance: No |

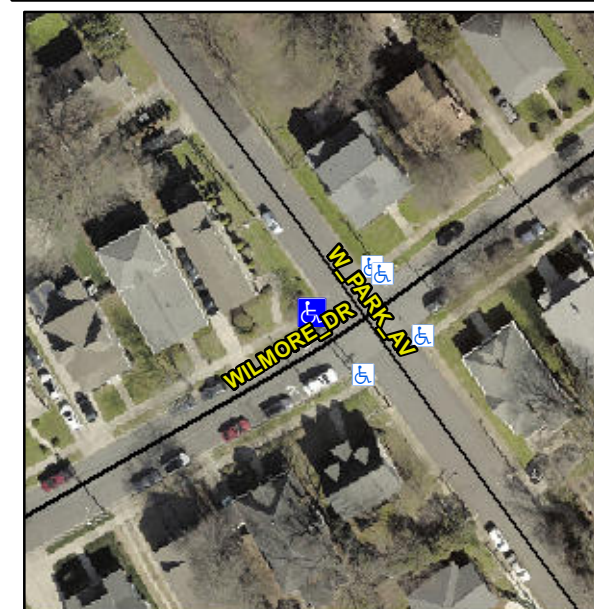
| Severity Score: 12.5 | | | |

**Not Found, R304.5.3**

| Compliance | Description | Data | Compliance | Description | Data |
|---|---|---|---|---|---|
| Yes | Ramp Width (in) | 48.0 | No | Ramp XSlope (%) | 6.1 |

**Remove & Replace Curb Ramp With Two New Directional Ramps or Equivalent.**

Total Cost: \$ 3200.00

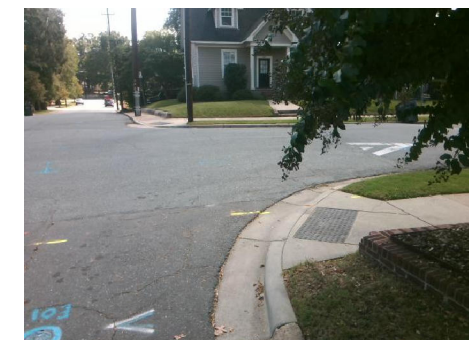
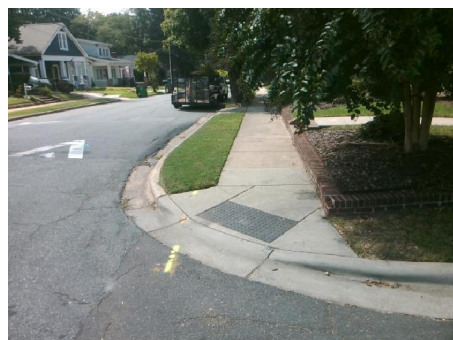
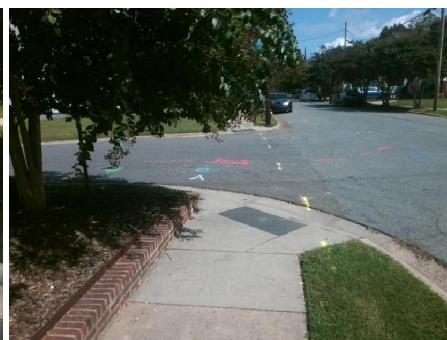
| Compliance | Description | Data | Compliance | Description | Data |
|---|---|---|---|---|---|
| | | Yes | | Surface Condition? (G/P) | Good |
