# Access Compliance Report

## Public Rights-of-Way

### (Curb Ramps)

Intersection ID: 21503	Main Street: BLUEBERRY_LN	Cross Street: PROVIDENCE_RD	Location: SW
ADA ID: 59B627F708AF	Ramp Type: PerpDiag	Initial Pass/Fail: Fail	Overall Compliance: No
Severity Score: 8.75			
Codes/Mitigation Info/Possible Solution		Field Measurements/Component Compliance

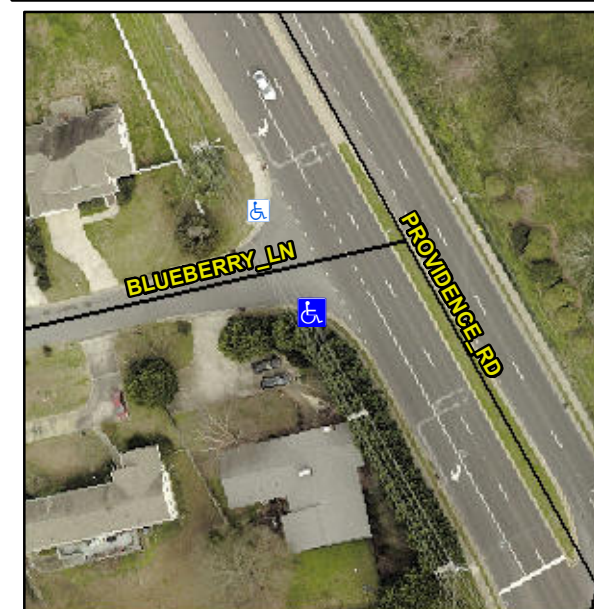
Compliance	Description	Data	Compliance	Description	Data
N/A	Ramp Length (in)	70.0	Yes	Ramp Slope (%)	6.6
No	Ramp Width (in)	36.0	Yes	Ramp XSlope (%)	1.4
N/A	Flare Type LT	N/A	N/A	Flare Type RT	N/A
N/A	Flare Slope LT (%)	N/A	N/A	Flare Slope RT (%)	N/A
N/A	Flare Traversable LT?	N/A	N/A	Flare Traversable RT?	N/A
N/A	Landing Length (in)	N/A	N/A	DWS Provided?	N/A
N/A	Landing Width (in)	N/A	N/A	DWS Contrast?	N/A
N/A	Landing Slope (%)	N/A	N/A	DWS Length (in)	N/A
N/A	Landing X Slope (%)	N/A	N/A	DWS Full Width?	N/A
N/A	Landing Curb? (Y/N)	N/A	N/A	DWS Offset (in)	N/A
N/A	Shared Landing?	N/A			
N/A	Gutter Ponding?	N/A	N/A	Gutter Slope (%)	N/A
N/A	Gutter Lip Ht (in)	N/A	N/A	Gutter X Slope (%)	N/A
N/A	Painted X Walk1?	No	N/A	Painted X Walk2?	No
	X Walk 1 Direction	To E		X Walk 2 Direction	To N
N/A	X Walk 1 Width (in)	N/A	N/A	X Walk 2 Width (in)	N/A
	X Walk 1 Slope (%)	1.4		X Walk 2 Slope (%)	1.0
	X Walk 1 X Slope (%)	0.4		X Walk 2 X Slope (%)	1.7

N/A	Ramp inside XWalk1?	N/A	N/A	Ramp inside XWalk2?	N/A
	Road Slope (%)	1.1	N/A	Clear Space?	N/A
	Road X Slope (%)	1.5	N/A	Clear Space to XWalk (in)	N/A
N/A	Any Obstructions?	N/A	N/A	Storm Grate/Utility Hazard?	N/A
	Obstruction Type			Storm Grate/Utility Type	
		N/A			N/A
		Yes		Surface Condition? (G/P)	Good

Possible Solutions:

**Remove & Replace Curb Ramp With Two New Directional Ramps or Equivalent.**

**Not Found, R304.5.1**
