Access Compliance Report

Public Rights-of-Way

(Curb Ramps)

| Intersection ID: 10207 | Main Street: JOYCE_DR | Cross Street: KILDARE_DR | Location: NE |

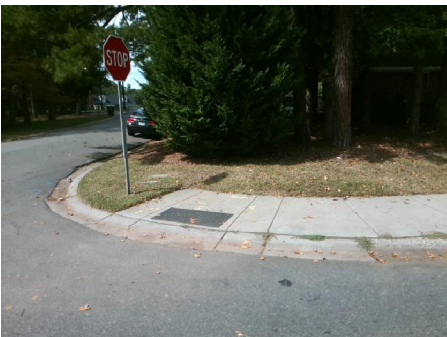
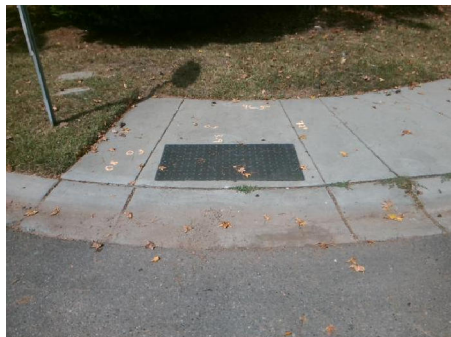
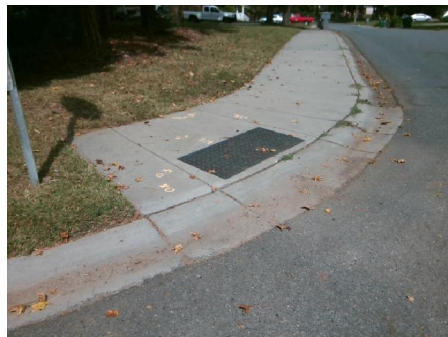
CURB LIP 1.0

Not Found, R304.5.1

| Compliance | Description | Data | Compliance | Description | Data |
|---|---|---|---|---|---|
| No | Ramp Width (in) | 46.5 | Yes | BlendTrans XSlope (%) | 0.5 |
| | | | No | Curb Slope (%) | 19.0 |

Remove & Replace Curb Ramp With Two New Directional Ramps or Equivalent.
