Access Compliance Report Public Rights-of-Way (Curb Ramps)

Intersection ID: 45175 Main Street: LINDEN_TREE_LN Cross Street: TORRELLE_DR Location: E

ADA ID: 59C7CA8BAFC7 Ramp Type: BlendTrans1 Initial Pass/Fail: Fail Overall Compliance: No Severity Score: 8.75

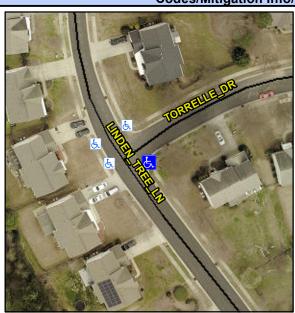
Not Found, R304.5.1

TORRELLE DR StopSign LINDEN TREE LN None Remove & Replace Curb Ramp With Two New Directional Ramps or Equivalent.
