Access Compliance Report Public Rights-of-Way (Curb Ramps)

Intersection ID: 17561 Main Street: BRIGHTON BROOK DR **Cross Street: BROOK CROSSING CT** Location: SE **ADA ID: 59CFD9BCDAF7** Ramp Type: PerpDiag Initial Pass/Fail: Fail **Overall Compliance: No Severity Score:** 12.5

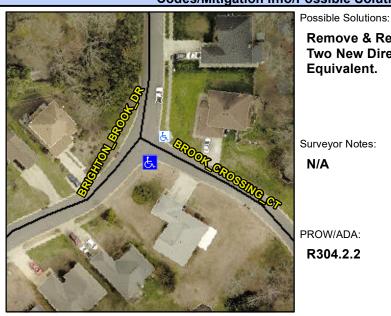
| Compliance Description | | Data | Compliance Description | | Data | |
|---|---|---|---|---|---|--|
| N/A | Ramp Length (in) | 52.0 | No | Ramp Slope (%) | 8.5 | |

Remove & Replace Curb Ramp With **Two New Directional Ramps or**

Total Cost: 3200.00
