# Access Compliance Report

## Public Rights-of-Way

### (Curb Ramps)

Intersection ID: 54137	Main Street: KEMP_ST	Cross Street: GLENBROWN_RD	Location: N
ADA ID: 59D84234765A	Ramp Type: Para	Initial Pass/Fail: Fail	Overall Compliance: No
Severity Score: 13.75			
Codes/Mitigation Info/Possible Solution		Field Measurements/Component Compliance

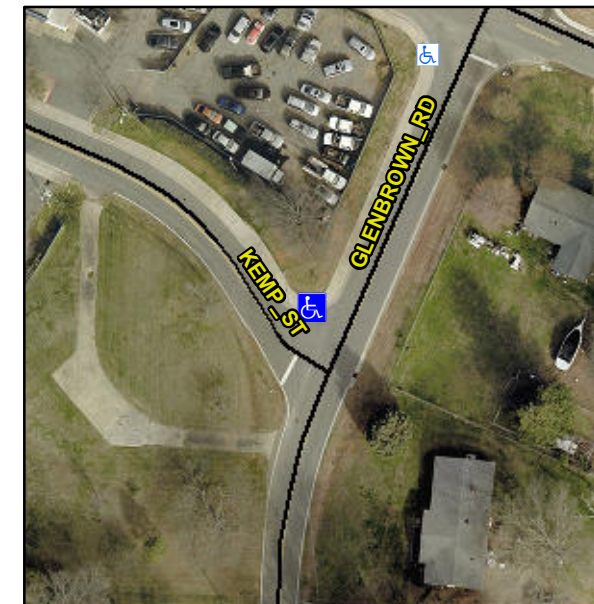
Compliance	Description	Data	Compliance	Description	Data
N/A	Ramp Length LT (in)	43.0	N/A	Ramp Length RT (in)	43.0
Yes	Ramp Width LT (in)	68.0	Yes	Ramp Width RT (in)	67.0
No	Ramp Slope LT (%)	10.2	Yes	Ramp Slope RT (%)	6.2
No	Ramp XSlope LT (%)	2.5	Yes	Ramp XSlope RT (%)	0.9
N/A	Landing Length (in)	N/A	N/A	DWS Provided?	N/A
N/A	Landing Width (in)	N/A	N/A	DWS Contrast?	N/A
N/A	Landing Slope (%)	N/A	N/A	DWS Length (in)	N/A
N/A	Landing X Slope (%)	N/A	N/A	DWS Full Width?	N/A
N/A	Landing Curb? (Y/N)	N/A	N/A	DWS Offset (in)	N/A
N/A	Shared Landing?	N/A			
N/A	Gutter Ponding?	N/A	N/A	Gutter Slope (%)	N/A
N/A	Gutter Lip Ht (in)	0.5	N/A	Gutter X Slope (%)	N/A
N/A	Painted X Walk1?	No	N/A	Painted X Walk2?	N/A
	X Walk 1 Direction	To S		X Walk 2 Direction	N/A
N/A	X Walk 1 Width (in)	N/A	N/A	X Walk 2 Width (in)	N/A
	X Walk 1 Slope (%)	2.6		X Walk 2 Slope (%)	N/A
	X Walk 1 X Slope (%)	2.2		X Walk 2 X Slope (%)	N/A
N/A	Ramp inside XWalk1?	N/A	N/A	Ramp inside XWalk2?	N/A

Road Slope (%)	N/A	N/A	Clear Space?	N/A
	Road X Slope (%)	N/A	N/A	Clear Space to XWalk (in)	N/A
N/A	Any Obstructions?	N/A	N/A	Storm Grate/Utility Hazard?	N/A
	Obstruction Type			Storm Grate/Utility Type	
		N/A			N/A
			Yes	Surface Condition? (G/P)	Good
			N/A	Curb Slope (%)	6.9

**Remove & Replace Entire Ramp.**

**R304.3.2, R304.5.3**
