Intersection ID: 12099	Main Street: KENNON_ST	Cross Street: THOMAS_AV	Location:	SW
ADA ID: 59DBFE759922	Ramp Type: Perp	Initial Pass/Fail: Fail	Overall Compliance: No	Severity Score: 12.5

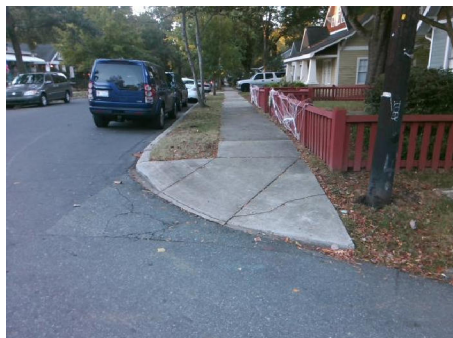
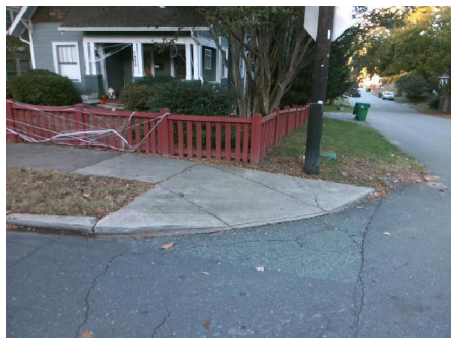
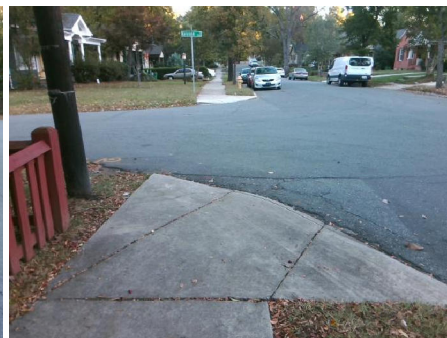
Possible Solutions:		Remove & Replace Entire Ramp.					
	Surveyor Notes:		N/A					
	PROW/ADA:		R304.2.2					
	Street 1 Name		KENNON ST					
	Stop Condition-Street 2		StopSign					
	Street 2 Name		N/A					
	Stop Condition-Street 1		N/A					
	Total Cost:		\$ 1850.00					
			Compliance	Description	Data	Compliance	Description	Data
			N/A	Ramp Length (in)	58.0	No	Ramp Slope (%)	10.1
			Yes	Ramp Width (in)	49.0	Yes	Ramp XSlope (%)	1.0
			N/A	Flare Type LT	N/A	N/A	Flare Type RT	N/A
			N/A	Flare Slope LT (%)	N/A	N/A	Flare Slope RT (%)	N/A
			N/A	Flare Traversable LT?	N/A	N/A	Flare Traversable RT?	N/A
			N/A	Landing Length (in)	N/A	N/A	DWS Provided?	N/A
			N/A	Landing Width (in)	N/A	N/A	DWS Contrast?	N/A
			N/A	Landing Slope (%)	N/A	N/A	DWS Length (in)	N/A
			N/A	Landing X Slope (%)	N/A	N/A	DWS Full Width?	N/A
			N/A	Landing Curb? (Y/N)	N/A	N/A	DWS Offset (in)	N/A
