Access Compliance Report

Public Rights-of-Way

(Curb Ramps)

Intersection ID: 44929	Main Street: TWIN_BROOK_DR	Cross Street: NATHAN_DR	Location: W
ADA ID: 59DD8CA9642C	Ramp Type: Perp	Initial Pass/Fail: Fail	Overall Compliance: No
		Severity Score: 8.75

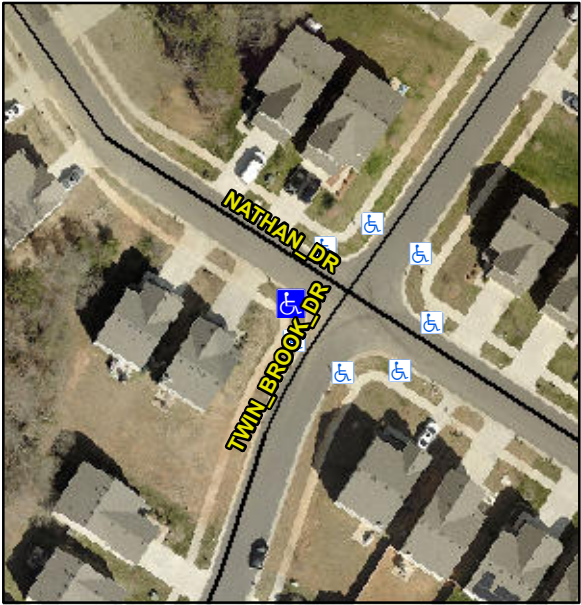
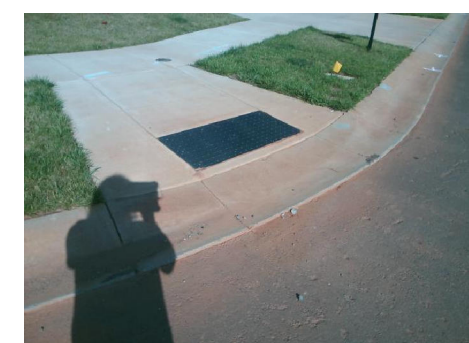
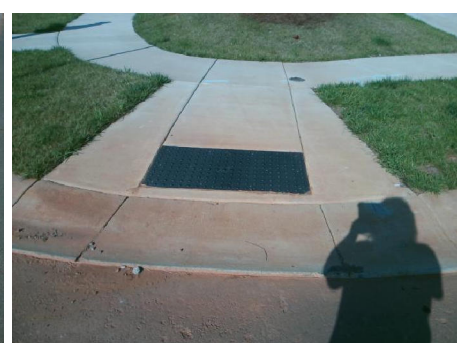
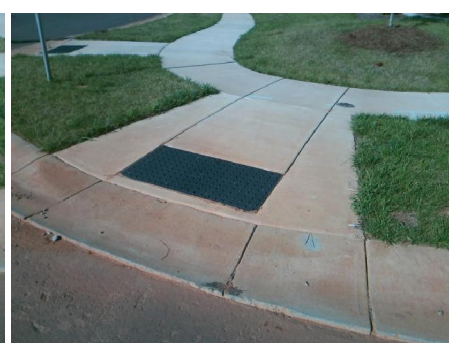
Possible Solutions:		Compliance	Description	Data
	Remove & Replace Entire Ramp.		Yes	Ramp Length (in)	94.5
			Yes	Ramp Width (in)	44.0
			N/A	Flare Type LT	N/A
			N/A	Flare Slope LT (%)	N/A
			N/A	Flare Traversable LT?	N/A
			N/A	Landing Length (in)	N/A
			N/A	Landing Width (in)	N/A
			N/A	Landing Slope (%)	N/A
			N/A	Landing X Slope (%)	N/A
<p>Surveyor Notes:</p> <p>N/A</p> <p>PROW/ADA:</p> <p>Not Found, R304.5.1</p>			N/A	Flare Type RT	N/A
			N/A	Flare Slope RT (%)	N/A
			N/A	Flare Traversable RT?	N/A
			N/A	DWS Provided?	N/A
			N/A	DWS Contrast?	N/A
			N/A	DWS Length (in)	N/A
			N/A	DWS Full Width?	N/A
			N/A	DWS Offset (in)	N/A
			N/A	Gutter Ponding?	N/A
			N/A	Gutter Lip Ht (in)	N/A
			No	Painted X Walk1?	N/A
				X Walk 1 Direction	To NW
			N/A	X Walk 1 Width (in)	N/A
				X Walk 1 Slope (%)	1.2
				X Walk 1 X Slope (%)	0.1

N/A	Ramp inside XWalk1?	N/A
			N/A	Ramp inside XWalk2?	N/A
			N/A	Road Slope (%)	N/A
			N/A	Road X Slope (%)	N/A
			N/A	Any Obstructions?	N/A
Total Cost:		\$ 1850.00		Obstruction Type	
			N/A	Storm Grate/Utility Hazard?	N/A
				Storm Grate/Utility Type	
			N/A		N/A
			Yes	Surface Condition? (G/P)	Good
