Access Compliance Report

Public Rights-of-Way

(Curb Ramps)

Intersection ID: 24705	Main Street: CHOATE_CR	Cross Street: CINNAMON_FIELD_RD	Location: SW
ADA ID: 59E660E11C30	Ramp Type: Perp	Initial Pass/Fail: Fail	Overall Compliance: No
Severity Score: 37.5			
Codes/Mitigation Info/Possible Solution		Field Measurements/Component Compliance

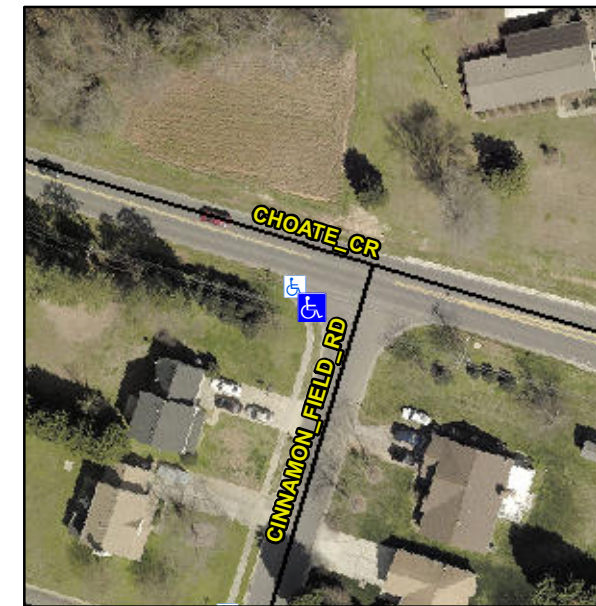
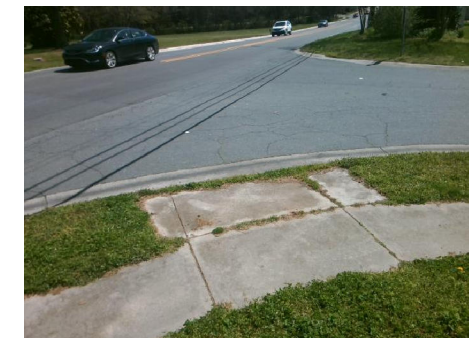
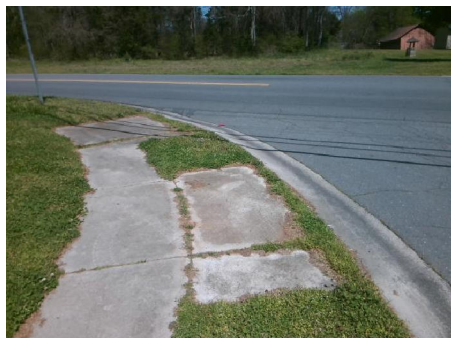
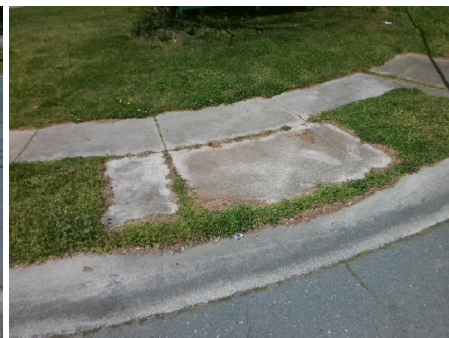
R304.2.2, R304.5.3

Compliance	Description	Data	Compliance	Description	Data
N/A	Ramp Length (in)	48.0	No	Ramp Slope (%)	9.0
Yes	Ramp Width (in)	64.0	No	Ramp XSlope (%)	7.5
N/A	Flare Type LT	N/A	N/A	Flare Type RT	N/A
N/A	Flare Slope LT (%)	N/A	N/A	Flare Slope RT (%)	N/A
N/A	Flare Traversable LT?	N/A	N/A	Flare Traversable RT?	N/A
N/A	Landing Length (in)	N/A	N/A	DWS Provided?	N/A
N/A	Landing Width (in)	N/A	N/A	DWS Contrast?	N/A
N/A	Landing Slope (%)	N/A	N/A	DWS Length (in)	N/A
N/A	Landing X Slope (%)	N/A	N/A	DWS Full Width?	N/A
N/A	Landing Curb? (Y/N)	N/A	N/A	DWS Offset (in)	N/A
N/A	Shared Landing?	N/A			
N/A	Gutter Ponding?	N/A	N/A	Gutter Slope (%)	N/A
N/A	Gutter Lip Ht (in)	N/A	N/A	Gutter X Slope (%)	N/A
N/A	Painted X Walk1?	No	N/A	Painted X Walk2?	N/A
	X Walk 1 Direction	To SE		X Walk 2 Direction	N/A
N/A	X Walk 1 Width (in)	N/A	N/A	X Walk 2 Width (in)	N/A
	X Walk 1 Slope (%)	1.9		X Walk 2 Slope (%)	N/A
	X Walk 1 X Slope (%)	5.3		X Walk 2 X Slope (%)	N/A

N/A	Ramp inside XWalk1?	N/A	N/A	Ramp inside XWalk2?	N/A
	Road Slope (%)	N/A	N/A	Clear Space?	N/A
	Road X Slope (%)	N/A	N/A	Clear Space to XWalk (in)	N/A
N/A	Any Obstructions?	N/A	N/A	Storm Grate/Utility Hazard?	N/A
	Obstruction Type			Storm Grate/Utility Type	
		N/A			N/A
			Yes	Surface Condition? (G/P)	Good

Possible Solutions:

Remove & Replace Entire Ramp.
