Access Compliance Report Public Rights-of-Way (Curb Ramps)

Intersection ID: 3584Main Street:DIXIE_ANN_DRCross Street:CHOWNING_TAVERN_LNLocation:SWADA ID: 59E75C1568D7Ramp Type:PerpDiagInitial Pass/Fail:FailOverall Compliance:NoSeverity Score:8.75

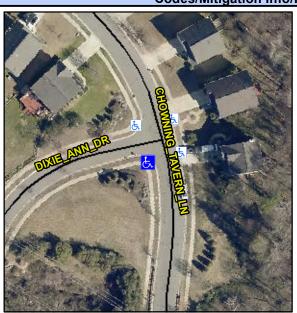
Not Found, R304.5.1

Compliance Description		Data	Compliance		Description	Data
N/A	Ramp Length (in)	61.0	Yes	Ram	Slope (%)	5.0
No	Ramp Width (in)	41.0	Yes	Ramp XSlope (%)		1.2
N/A	Flare Type LT	N/A	N/A	Flare Type RT		N/A
N/A	Flare Slope LT (%)	N/A	N/A	Flare	Slope RT (%)	N/A
N/A	Flare Traversable LT?	N/A	N/A	Flare	Traversable RT?	N/A
N/A	Landing Length (in)	N/A	N/A	DWS	Provided?	N/A
N/A	Landing Width (in)	N/A	N/A	DWS	Contrast?	N/A
N/A	Landing Slope (%)	N/A	N/A	DWS	Length (in)	N/A
N/A	Landing X Slope (%)	N/A	N/A	DWS	Full Width?	N/A
N/A	Landing Curb? (Y/N)	N/A	N/A	DWS	Offset (in)	N/A
N/A	Shared Landing?	N/A				
N/A	Gutter Ponding?	N/A	N/A	Gutte	er Slope (%)	N/A
N/A	Gutter Lip Ht (in)	N/A	N/A	Gutte	er X Slope (%)	N/A
N/A	Painted X Walk1?	No	N/A	Paint	ed X Walk2?	No
	X Walk 1 Direction	То Е		X Wa	lk 2 Direction	To N
N/A	X Walk 1 Width (in)	N/A	N/A	X Wa	lk 2 Width (in)	N/A
	X Walk 1 Slope (%)	0.7		X Wa	lk 2 Slope (%)	1.9
	X Walk 1 X Slope (%)	2.9		X Wa	lk 2 X Slope (%)	0.0

N/A	Ramp inside XWalk1?	N/A	N/A	Ram	o inside XWalk2?	N/A
	Road Slope (%)	1.7	N/A	Clear	Space?	N/A
	Road X Slope (%)	2.7	N/A	Clear	Space to XWalk (in)	N/A
N/A	Any Obstructions?	N/A	N/A	Storn	n Grate/Utility Hazard?	N/A
	Obstruction Type		l	Storn	n Grate/Utility Type	
		N/A				N/A

Remove & Replace Curb Ramp With Two New Directional Ramps or Equivalent.

Total Cost: \$ 3200.00
