Access Compliance Report Public Rights-of-Way (Curb Ramps)

Intersection ID: 28914 Main Street: PINEVILLE-MATTHEWS_RD Cross Street: SPRINGBANK_LN Location: NW

ADA ID: 59F198262A6D Ramp Type: PerpDiag Initial Pass/Fail: Pass Overall Compliance: No Severity Score: 19.25

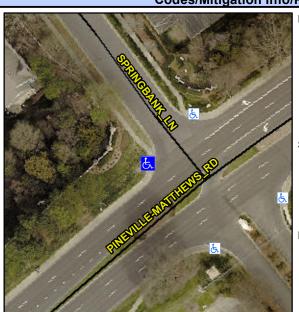
Not Found, R304.5.3, R304.2.1, R305, R304.5.4

Field Measurements/Component Compliance					
Compliance Description		Data	Comp	liance Description	Data
N/A	Ramp Length (in)	59.0	Yes	Ramp Slope (%)	8.0
Yes	Ramp Width (in)	50.0	No	Ramp XSlope (%)	2.9
N/A	Flare Type LT	Sloped	N/A	Flare Type RT	N/A
N/A	Flare Slope LT (%)	7.2	Yes	Flare Slope RT (%)	1.6
N/A	Flare Traversable LT?	Yes	N/A	Flare Traversable RT?	Yes
No	Landing Length (in)	36.0	No	DWS Provided?	No
No	Landing Width (in)	46.0	N/A	DWS Contrast?	No
Yes	Landing Slope (%)	1.4	N/A	DWS Length (in)	N/A
Yes	Landing X Slope (%)	1.6	N/A	DWS Full Width?	No
N/A	Landing Curb? (Y/N)	No	N/A	DWS Offset (in)	N/A
N/A	Shared Landing?	No			
Yes	Gutter Ponding?	No	No	Gutter Slope (%)	5.1
Yes	Gutter Lip Ht (in)	0.0	No	Gutter X Slope (%)	2.8
N/A	Painted X Walk1?	No	N/A	Painted X Walk2?	No
	X Walk 1 Direction	To S		X Walk 2 Direction	To NE
N/A	X Walk 1 Width (in)	N/A	N/A	X Walk 2 Width (in)	N/A
	X Walk 1 Slope (%)	0.7		X Walk 2 Slope (%)	2.0

X Walk 1 X Slope (%)	0.1		X Walk 2 X Slope (%)	1.7
N/A	Ramp inside XWalk1?	N/A	N/A	Ramp inside XWalk2?	N/A
	Road Slope (%)	2.8	N/A	Clear Space?	Yes
	Road X Slope (%)	0.3	N/A	Clear Space to XWalk (in)	N/A
Yes	Any Obstructions?	No	Yes	Storm Grate/Utility Hazard?	No
	Obstruction Type		l	Storm Grate/Utility Type	
		N/A			N/A
			Yes	Surface Condition? (G/P)	Good
	ALL STREET

Remove & Replace Curb Ramp With Two New Directional Ramps or Equivalent. Remove & Replace Gutter.
