# Access Compliance Report

## Public Rights-of-Way

### (Curb Ramps)

Intersection ID: 43737	Main Street: ASHLYN_CHASE_CT	Cross Street: BRIDGEVIEW_LN	Location:	N
ADA ID: 59F862E5176F	Ramp Type: BlendTrans1	Initial Pass/Fail: Fail	Overall Compliance: No	Severity Score: 1.25
Codes/Mitigation Info/Possible Solution		Field Measurements/Component Compliance

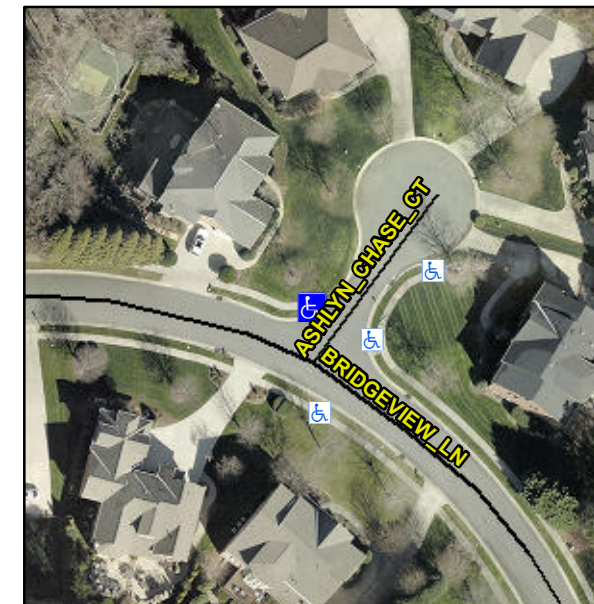
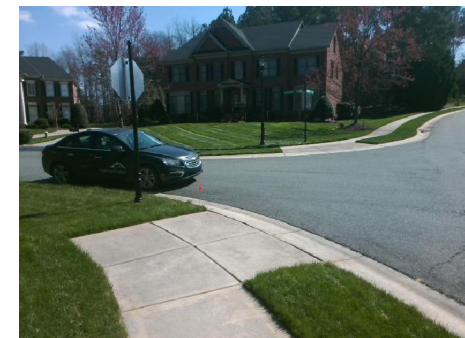
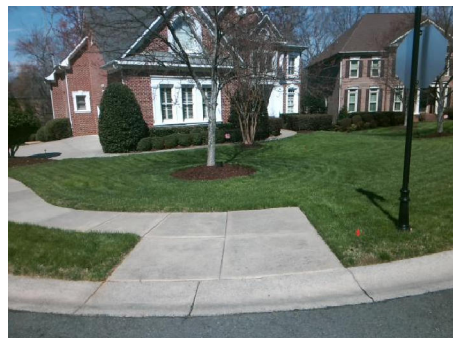
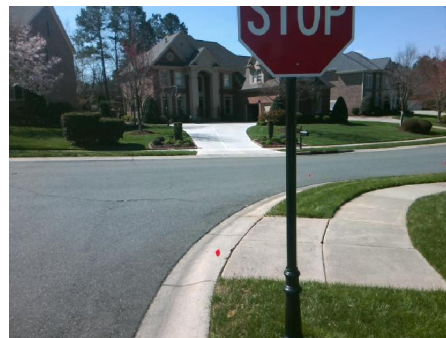
**GTR GAP 2.5, LNDG GAP 1.5**

**Not Found, R304.5.3**

Compliance	Description	Data	Compliance	Description	Data
N/A	Ramp Length (in)	47.0	Yes	BlendTrans Slope (%)	3.5
Yes	Ramp Width (in)	48.0	No	BlendTrans XSlope (%)	3.5
N/A	Flare Type LT	N/A	N/A	Flare Type RT	N/A
N/A	Flare Slope LT (%)	N/A	N/A	Flare Slope RT (%)	N/A
N/A	Flare Traversable LT?	N/A	N/A	Flare Traversable RT?	N/A
N/A	Landing Length (in)	N/A	N/A	DWS Provided?	N/A
N/A	Landing Width (in)	N/A	N/A	DWS Contrast?	N/A
N/A	Landing Slope (%)	N/A	N/A	DWS Length (in)	N/A
N/A	Landing X Slope (%)	N/A	N/A	DWS Full Width?	N/A
N/A	Landing Curb? (Y/N)	N/A	N/A	DWS Offset (in)	N/A
N/A	Shared Landing?	N/A			
N/A	Gutter Ponding?	N/A	N/A	Gutter Slope (%)	N/A
N/A	Gutter Lip Ht (in)	N/A	N/A	Gutter X Slope (%)	N/A
N/A	Painted X Walk1?	No	N/A	Painted X Walk2?	N/A
	X Walk 1 Direction	To SE		X Walk 2 Direction	N/A
	X Walk 1 Width (in)	N/A		X Walk 2 Width (in)	N/A
	X Walk 1 Slope (%)	8.9		X Walk 2 Slope (%)	N/A
	X Walk 1 X Slope (%)	1.5		X Walk 2 X Slope (%)	N/A

N/A	Ramp inside XWalk1?	N/A	N/A	Ramp inside XWalk2?	N/A
	Road Slope (%)	1.5		Clear Space?	N/A
	Road X Slope (%)	8.9	N/A	Clear Space to XWalk (in)	N/A
N/A	Any Obstructions?	N/A	N/A	Storm Grate/Utility Hazard?	N/A
	Obstruction Type			Storm Grate/Utility Type	
		N/A			N/A
			Yes	Surface Condition? (G/P)	Good
			No	Curb Slope (%)	11.3

**Remove & Replace Curb Ramp With Two New Directional Ramps or Equivalent.**
