Access Compliance Report

Public Rights-of-Way

(Curb Ramps)

Intersection ID: 8526	Main Street: LANEWOOD_PL	Cross Street: WESTRIDGE_DR	Location: SW
ADA ID: 59FCF1BD385C	Ramp Type: Perp	Initial Pass/Fail: Fail	Overall Compliance: No
Severity Score: 26.25			
Codes/Mitigation Info/Possible Solution		Field Measurements/Component Compliance

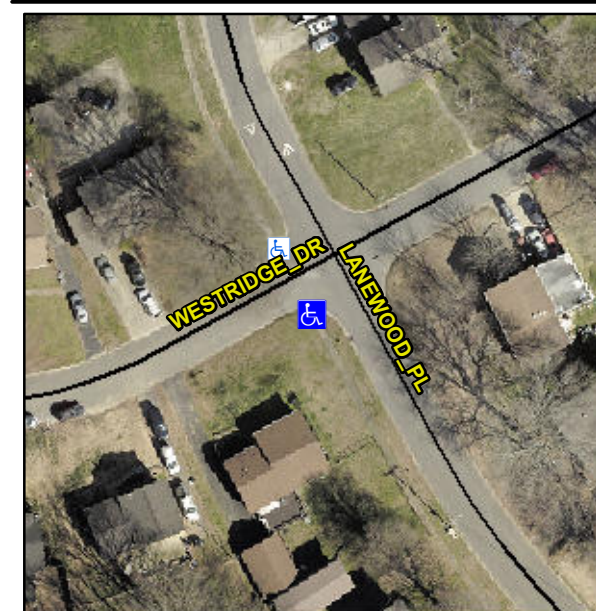
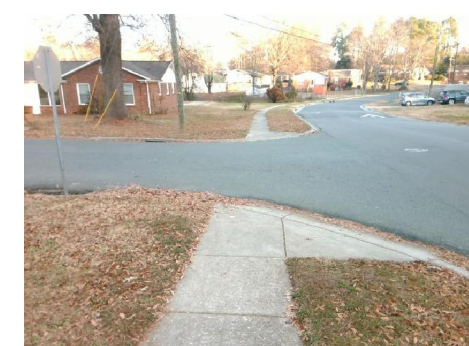
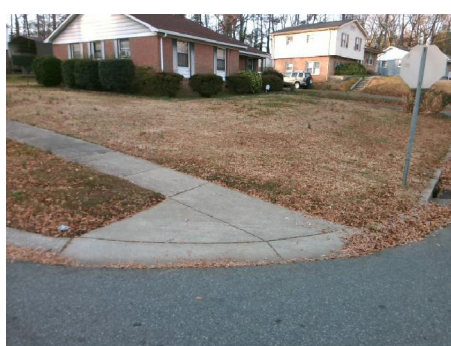
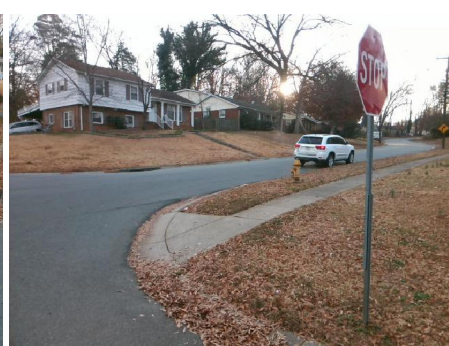
Not Found, R304.2.2, R304.5.3

Compliance	Description	Data	Compliance	Description	Data
N/A	Ramp Length (in)	46.0	No	Ramp Slope (%)	14.4
Yes	Ramp Width (in)	48.0	No	Ramp XSlope (%)	4.8
N/A	Flare Type LT	N/A	N/A	Flare Type RT	N/A
N/A	Flare Slope LT (%)	N/A	N/A	Flare Slope RT (%)	N/A
N/A	Flare Traversable LT?	N/A	N/A	Flare Traversable RT?	N/A
N/A	Landing Length (in)	N/A	N/A	DWS Provided?	N/A
N/A	Landing Width (in)	N/A	N/A	DWS Contrast?	N/A
N/A	Landing Slope (%)	N/A	N/A	DWS Length (in)	N/A
N/A	Landing X Slope (%)	N/A	N/A	DWS Full Width?	N/A
N/A	Landing Curb? (Y/N)	N/A	N/A	DWS Offset (in)	N/A
N/A	Shared Landing?	N/A			
N/A	Gutter Ponding?	N/A	N/A	Gutter Slope (%)	N/A
N/A	Gutter Lip Ht (in)	3.0	N/A	Gutter X Slope (%)	N/A
N/A	Painted X Walk1?	No	N/A	Painted X Walk2?	N/A
	X Walk 1 Direction	To N		X Walk 2 Direction	N/A
N/A	X Walk 1 Width (in)	N/A	N/A	X Walk 2 Width (in)	N/A
	X Walk 1 Slope (%)	1.5		X Walk 2 Slope (%)	N/A
	X Walk 1 X Slope (%)	5.2		X Walk 2 X Slope (%)	N/A

N/A	Ramp inside XWalk1?	N/A	N/A	Ramp inside XWalk2?	N/A
	Road Slope (%)	N/A	N/A	Clear Space?	N/A
	Road X Slope (%)	N/A	N/A	Clear Space to XWalk (in)	N/A
N/A	Any Obstructions?	N/A	N/A	Storm Grate/Utility Hazard?	N/A
	Obstruction Type			Storm Grate/Utility Type	
		N/A			N/A
			Yes	Surface Condition? (G/P)	Good

Remove & Replace Entire Ramp.

Total Cost: \$ 1850.00
