Access Compliance Report

Public Rights-of-Way

(Curb Ramps)

Intersection ID: 10023017	Main Street: CENTER_PARK_DR	Cross Street: N/A	Location: NW
ADA ID: 5A016117BA08	Ramp Type: BlendTrans1	Initial Pass/Fail: Fail	Overall Compliance: No
			Severity Score: 33.75

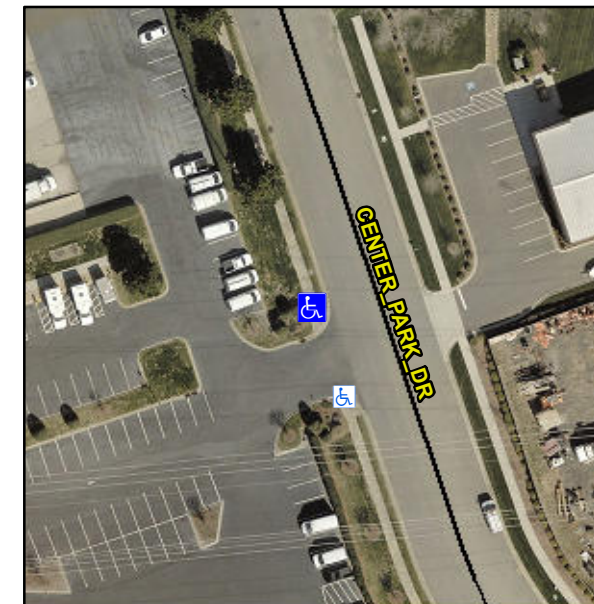
Not Found, R304.5.1, R304.5.3

Compliance	Description	Data	Compliance	Description	Data
N/A	Ramp Length (in)	76.0	Yes	BlendTrans Slope (%)	2.3
No	Ramp Width (in)	46.0	No	BlendTrans XSlope (%)	9.5
N/A	Flare Type LT	N/A	N/A	Flare Type RT	N/A
N/A	Flare Slope LT (%)	N/A	N/A	Flare Slope RT (%)	N/A
N/A	Flare Traversable LT?	N/A	N/A	Flare Traversable RT?	N/A
N/A	Landing Length (in)	N/A	N/A	DWS Provided?	N/A
N/A	Landing Width (in)	N/A	N/A	DWS Contrast?	N/A
N/A	Landing Slope (%)	N/A	N/A	DWS Length (in)	N/A
N/A	Landing X Slope (%)	N/A	N/A	DWS Full Width?	N/A
N/A	Landing Curb? (Y/N)	N/A	N/A	DWS Offset (in)	N/A
N/A	Shared Landing?	N/A			
N/A	Gutter Ponding?	N/A	N/A	Gutter Slope (%)	N/A
N/A	Gutter Lip Ht (in)	N/A	N/A	Gutter X Slope (%)	N/A
N/A	Painted X Walk1?	No	N/A	Painted X Walk2?	No
	X Walk 1 Direction	To S		X Walk 2 Direction	To E
	X Walk 1 Width (in)	N/A		X Walk 2 Width (in)	N/A
	X Walk 1 Slope (%)	2.6		X Walk 2 Slope (%)	8.5
	X Walk 1 X Slope (%)	7.0		X Walk 2 X Slope (%)	4.4

N/A	Ramp inside XWalk1?	N/A	N/A	Ramp inside XWalk2?	N/A
	Road Slope (%)	3.9		Clear Space?	N/A
	Road X Slope (%)	0.7	N/A	Clear Space to XWalk (in)	N/A
N/A	Any Obstructions?	N/A	N/A	Storm Grate/Utility Hazard?	N/A
	Obstruction Type			Storm Grate/Utility Type	
		N/A			N/A
			Yes	Surface Condition? (G/P)	Good
			No	Curb Slope (%)	13.3

Remove & Replace Curb Ramp With Two New Directional Ramps or Equivalent.
