# Access Compliance Report

## Public Rights-of-Way

### (Curb Ramps)

Intersection ID: 2711	Main Street: FAIRWAY_POINT_DR	Cross Street: HIGHLAND_CREEK_PY	Location: SW
ADA ID: 5A05042CC97A	Ramp Type: PerpDiag	Initial Pass/Fail: Fail	Overall Compliance: No
Severity Score: 37.5			
Codes/Mitigation Info/Possible Solution		Field Measurements/Component Compliance

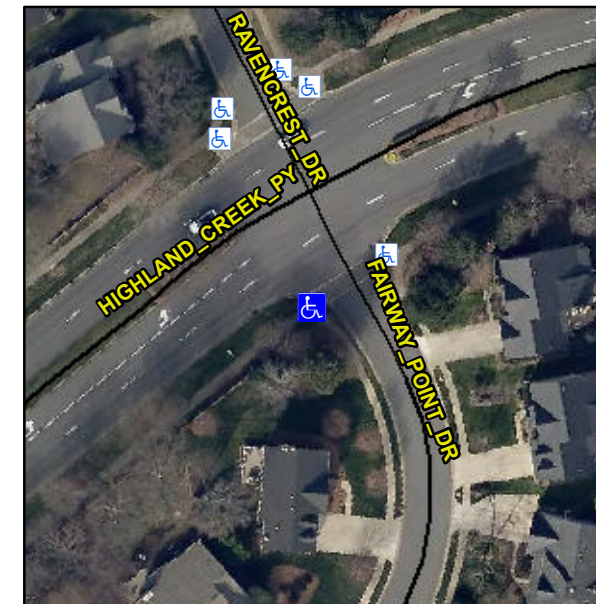
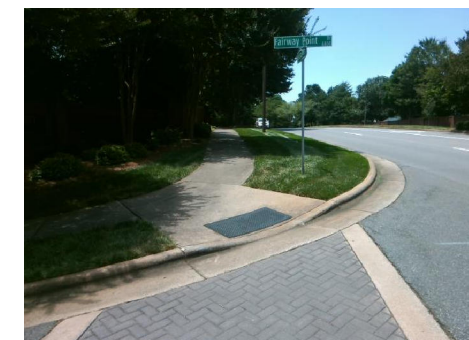
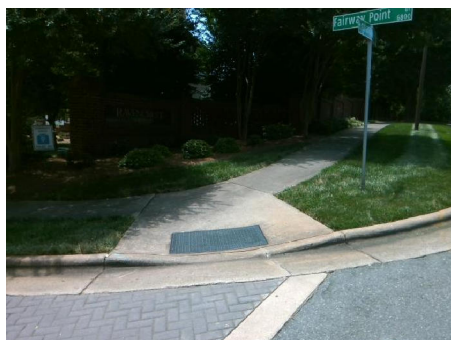
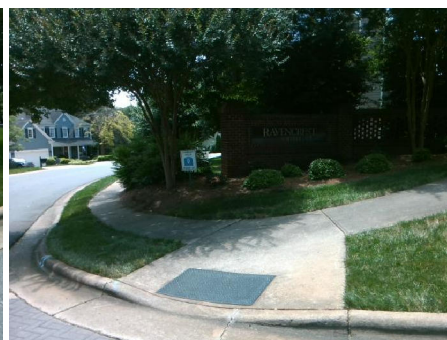
Compliance	Description	Data	Compliance	Description	Data
N/A	Ramp Length (in)	53.0	No	Ramp Slope (%)	11.5
Yes	Ramp Width (in)	48.0	No	Ramp XSlope (%)	13.7
N/A	Flare Type LT	N/A	N/A	Flare Type RT	N/A
N/A	Flare Slope LT (%)	N/A	N/A	Flare Slope RT (%)	N/A
N/A	Flare Traversable LT?	N/A	N/A	Flare Traversable RT?	N/A
N/A	Landing Length (in)	N/A	N/A	DWS Provided?	N/A
N/A	Landing Width (in)	N/A	N/A	DWS Contrast?	N/A
N/A	Landing Slope (%)	N/A	N/A	DWS Length (in)	N/A
N/A	Landing X Slope (%)	N/A	N/A	DWS Full Width?	N/A
N/A	Landing Curb? (Y/N)	N/A	N/A	DWS Offset (in)	N/A
N/A	Shared Landing?	N/A			
N/A	Gutter Ponding?	N/A	N/A	Gutter Slope (%)	N/A
N/A	Gutter Lip Ht (in)	N/A	N/A	Gutter X Slope (%)	N/A
N/A	Painted X Walk1?	No	N/A	Painted X Walk2?	No
	X Walk 1 Direction	To E		X Walk 2 Direction	To N
N/A	X Walk 1 Width (in)	N/A	N/A	X Walk 2 Width (in)	N/A
	X Walk 1 Slope (%)	8.3		X Walk 2 Slope (%)	4.6
	X Walk 1 X Slope (%)	3.8		X Walk 2 X Slope (%)	6.6

N/A	Ramp inside XWalk1?	N/A	N/A	Ramp inside XWalk2?	N/A
	Road Slope (%)	11.3	N/A	Clear Space?	N/A
	Road X Slope (%)	3.5	N/A	Clear Space to XWalk (in)	N/A
N/A	Any Obstructions?	N/A	N/A	Storm Grate/Utility Hazard?	N/A
	Obstruction Type			Storm Grate/Utility Type	
		N/A			N/A
		Yes		Surface Condition? (G/P)	Good

Possible Solutions:

**Remove & Replace Curb Ramp With Two New Directional Ramps or Equivalent.**

**R304.2.2, R304.5.3**

Total Cost: \$ 3200.00
