# Access Compliance Report

## Public Rights-of-Way

### (Curb Ramps)

| Intersection ID: 23292 | Main Street: SHARON_RD_WEST | Cross Street: RIVERBIRCH_DR | Location: NE |

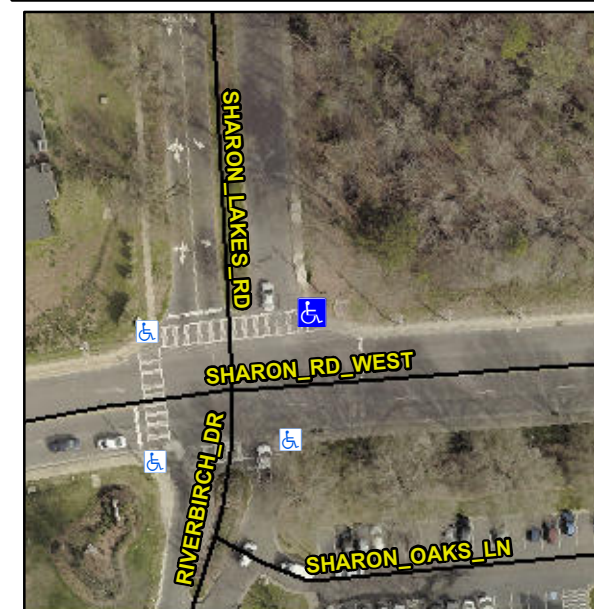
| ADA ID: 5A08A26D358E | Ramp Type: PerpDiag | Initial Pass/Fail: Pass | Overall Compliance: No |
| Severity Score: 10 | | | |

**Not Found, R304.2.1, R304.2.2-Perp, R304.3.2-Para, R304.5.3, R305.2**

| Compliance | Description | Data | Compliance | Description | Data |
|---|---|---|---|---|---|
| No | Landing Length (in) | N/A | Yes | DWS Provided? | Yes |
| No | Landing Width (in) | N/A | Yes | DWS Contrast? | Yes |
| No | Landing Slope (%) | N/A | Yes | DWS Length (in) | 24.0 |
| No | Landing X Slope (%) | N/A | Yes | DWS Full Width? | Yes |
| N/A | Landing Curb? (Y/N) | No | No | DWS Offset (in) | 9.0 |

Possible Solutions:

**Remove & Replace Curb Ramp With Two New Directional Ramps or Equivalent.**

Total Cost: \$ 3200.00
