Access Compliance Report Public Rights-of-Way (Curb Ramps)

Intersection ID: 18567 Main Street: MICHAEL_BAKER_PL Cross Street: RUNNYMEDE_LN Location: SE ADA ID: 5A092127C212 Ramp Type: Perp Initial Pass/Fail: Fail **Overall Compliance: No** Severity Score: 21.25

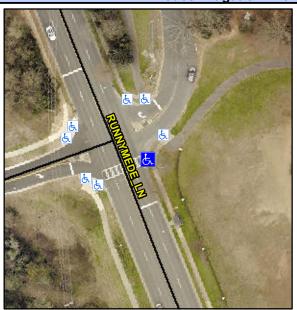
Field Measurements/Component Compliance								
Comp	liance Description	Data	Comp	liance	Description	Data		
N/A	Ramp Length (in)	46.0	No	Ramp	Slope (%)	11.3		
No	Ramp Width (in)	47.0	Yes	Ramp	XSlope (%)	0.2		
N/A	Flare Type LT	N/A	N/A	Flare	Type RT	N/A		
N/A	Flare Slope LT (%)	N/A	N/A Flare Slope RT (%)		Slope RT (%)	N/A		
N/A	Flare Traversable LT?	N/A	N/A	Flare	Traversable RT?	N/A		
N/A	Landing Length (in)	N/A	N/A	DWS	Provided?	N/A		
N/A	Landing Width (in)	N/A	N/A	DWS	Contrast?	N/A		
N/A	Landing Slope (%)	N/A	N/A	DWS	Length (in)	N/A		
N/A	Landing X Slope (%)	N/A	N/A	DWS	Full Width?	N/A		
N/A	Landing Curb? (Y/N)	N/A	N/A	DWS	Offset (in)	N/A		
N/A	Shared Landing?	N/A						
N/A	Gutter Ponding?	N/A	N/A	Gutte	r Slope (%)	N/A		
N/A	Gutter Lip Ht (in)	N/A	N/A	Gutte	r X Slope (%)	N/A		
N/A	Painted X Walk1?	Yes	N/A	Paint	ed X Walk2?	N/A		
	X Walk 1 Direction	To SW		X Wa	lk 2 Direction	N/A		
N/A	X Walk 1 Width (in)	104.0	N/A	X Wa	lk 2 Width (in)	N/A

i ossible solution	
Possible Solutions:	Con
Remove & Replace Entire Ramp.	N/A
·	No
	N/A
	N/A
	N/A
	N/A
Surveyor Notes:	N/A
N/A	N/A
	N/A
	N/A
	N/A
PROW/ADA:	N/A
R304.5.1, R304.2.2	N/A
	N/A
	N/A
	N/A
