Access Compliance Report

Public Rights-of-Way (Curb Ramps)

Intersection ID: 17962	Main Street: S_TRYON_ST	Cross Street: SKIPWITH_PL	Location: SE
ADA ID: 5A128A1A6EBA	Ramp Type: Directional1	Initial Pass/Fail: Fail	Overall Compliance: No
		Severity Score: 1.25

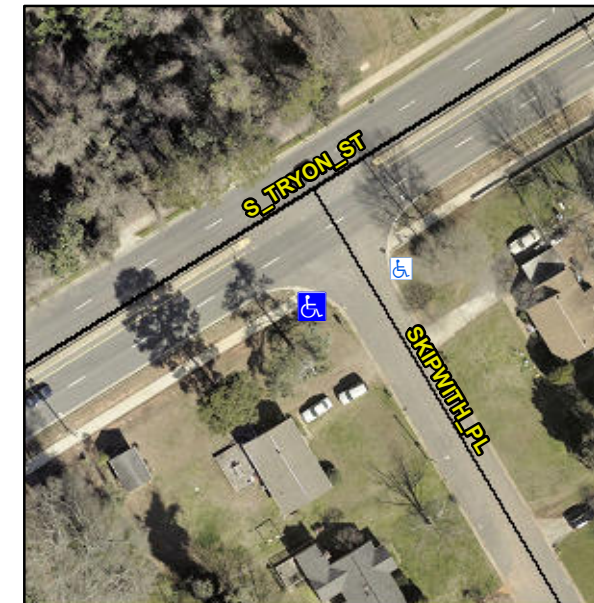
N/A

Compliance	Description	Data	Compliance	Description	Data
N/A	Ramp Length (in)	78.0	N/A	Grade Break?	N/A
Yes	Ramp Width (in)	72.0	N/A	Grade Break Slope (%)	0.0
Yes	Ramp Slope (%)	6.9	N/A	Grade Break XSlope (%)	0.0
No	Ramp XSlope (%)	2.6			
N/A	Flare Type LT	N/A	N/A	Flare Type RT	N/A
N/A	Flare Slope LT (%)	N/A	N/A	Flare Slope RT (%)	0.0
N/A	Flare Traversable LT?	N/A	N/A	Flare Traversable RT?	N/A
N/A	Landing Length (in)	0.0	N/A	DWS Provided?	N/A
N/A	Landing Width (in)	0.0	N/A	DWS Contrast?	N/A
N/A	Landing Slope (%)	0.0	N/A	DWS Length (in)	N/A
N/A	Landing X Slope (%)	0.0	N/A	DWS Full Width?	N/A
N/A	Landing Curb? (Y/N)	N/A	N/A	DWS Offset LT (in)	N/A
N/A	Shared Landing?	N/A	N/A	DWS Offset RT (in)	N/A
N/A	Gutter Ponding?	0.0	N/A	Gutter Slope (%)	N/A
N/A	Gutter Lip Ht (in)	0.5	N/A	Gutter X Slope (%)	N/A
N/A	Painted X Walk1?	No		Road Slope (%)	0.5
	X Walk 1 Direction	To NE		Road X Slope (%)	0.4
	X Walk 1 Width (in)	N/A		Clear Space?	N/A

X Walk 1 Slope (%)	0.5	N/A	Clear Space to XWalk (in)	N/A
	X Walk 1 X Slope (%)	0.4	N/A	Storm Grate/Utility Hazard?	N/A
N/A	Ramp inside XWalk1?	N/A		Storm Grate/Utility Type	
N/A	Any Obstructions?	N/A			N/A
	Obstruction Type		Yes	Surface Condition? (G/P)	Good
			N/A	Curb Slope (%)	2.7

Possible Solutions:

Remove & Replace Entire Ramp.

R304.5.3

Total Cost: \$ 1600.00
