# Access Compliance Report

## Public Rights-of-Way

### (Curb Ramps)

Intersection ID: 29501	Main Street: REDDMAN_RD	Cross Street: SOUTHWOOD_OAKS_LN	Location: SE
ADA ID: 5A20A44ACCAA	Ramp Type: PerpDiag	Initial Pass/Fail: Fail	Overall Compliance: No
		Severity Score: 25

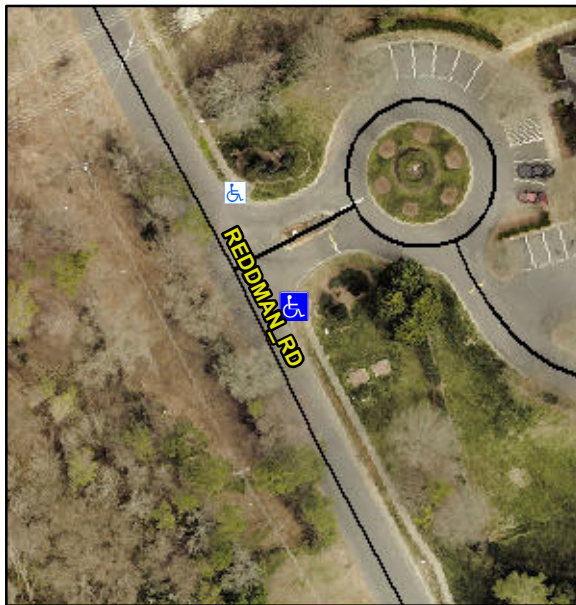
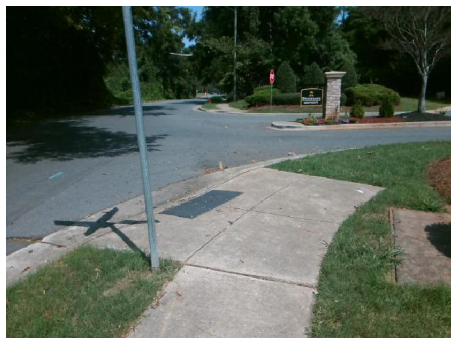
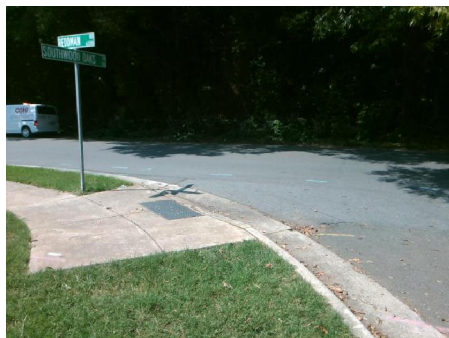
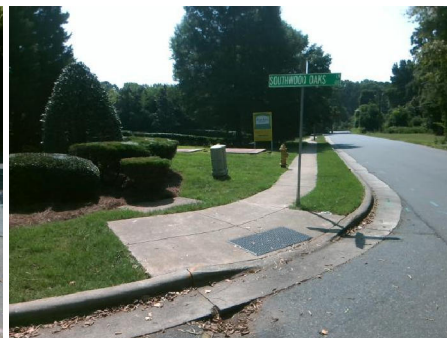
**Not Found, R304.5.3**

Compliance	Description	Data	Compliance	Description	Data
N/A	Ramp Length (in)	47.0	Yes	Ramp Slope (%)	8.1
Yes	Ramp Width (in)	48.0	No	Ramp XSlope (%)	8.0
N/A	Flare Type LT	N/A	N/A	Flare Type RT	N/A
N/A	Flare Slope LT (%)	N/A	N/A	Flare Slope RT (%)	N/A
N/A	Flare Traversable LT?	N/A	N/A	Flare Traversable RT?	N/A
N/A	Landing Length (in)	N/A	N/A	DWS Provided?	N/A
N/A	Landing Width (in)	N/A	N/A	DWS Contrast?	N/A
N/A	Landing Slope (%)	N/A	N/A	DWS Length (in)	N/A
N/A	Landing X Slope (%)	N/A	N/A	DWS Full Width?	N/A
N/A	Landing Curb? (Y/N)	N/A	N/A	DWS Offset (in)	N/A
N/A	Shared Landing?	N/A			
N/A	Gutter Ponding?	N/A	N/A	Gutter Slope (%)	N/A
N/A	Gutter Lip Ht (in)	N/A	N/A	Gutter X Slope (%)	N/A
N/A	Painted X Walk1?	No	N/A	Painted X Walk2?	No
	X Walk 1 Direction	To NW		X Walk 2 Direction	To W
N/A	X Walk 1 Width (in)	N/A	N/A	X Walk 2 Width (in)	N/A
	X Walk 1 Slope (%)	2.9		X Walk 2 Slope (%)	0.7
	X Walk 1 X Slope (%)	2.6		X Walk 2 X Slope (%)	4.8

N/A	Ramp inside XWalk1?	N/A	N/A	Ramp inside XWalk2?	N/A
	Road Slope (%)	5.6	N/A	Clear Space?	N/A
	Road X Slope (%)	3.9	N/A	Clear Space to XWalk (in)	N/A
N/A	Any Obstructions?	N/A	N/A	Storm Grate/Utility Hazard?	N/A
	Obstruction Type			Storm Grate/Utility Type	
		N/A			N/A
		Yes		Surface Condition? (G/P)	Good

**Remove & Replace Curb Ramp With Two New Directional Ramps or Equivalent.**

Total Cost: \$ 3200.00
