Access Compliance Report

Public Rights-of-Way

(Curb Ramps)

Intersection ID: 44723	Main Street: PROSPERITY_CHURCH_RD	Cross Street: JOHNSTON_OEHLER_RD	Location: NW
ADA ID: 5A2610B8BE54	Ramp Type: IslandPerp	Initial Pass/Fail: Fail	Overall Compliance: No
		Severity Score: 12.5

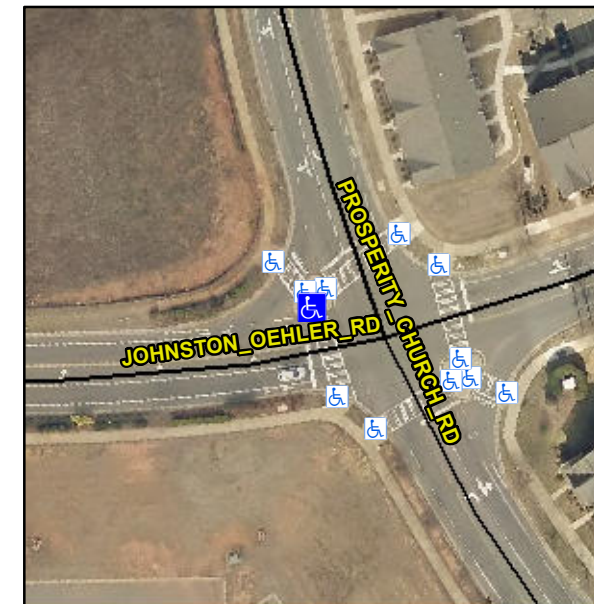
Compliance	Description	Data	Compliance	Description	Data
N/A	Ramp Length (in)	66.0	No	Ramp Slope (%)	11.6
Yes	Ramp Width (in)	50.0	Yes	Ramp XSlope (%)	0.7
N/A	Flare Type LT	N/A	N/A	Flare Type RT	N/A
N/A	Flare Slope LT (%)	N/A	N/A	Flare Slope RT (%)	N/A
N/A	Flare Traversable LT?	N/A	N/A	Flare Traversable RT?	N/A
N/A	Landing Length (in)	N/A	N/A	DWS Provided?	N/A
N/A	Landing Width (in)	N/A	N/A	DWS Contrast?	N/A
N/A	Landing Slope (%)	N/A	N/A	DWS Length (in)	N/A
N/A	Landing X Slope (%)	N/A	N/A	DWS Full Width?	N/A
N/A	Landing Curb? (Y/N)	N/A	N/A	DWS Offset (in)	N/A
N/A	Shared Landing?	N/A			
N/A	Gutter Ponding?	N/A	N/A	Gutter Slope (%)	N/A
N/A	Gutter Lip Ht (in)	N/A	N/A	Gutter X Slope (%)	N/A
N/A	Painted X Walk1?	Yes	N/A	Painted X Walk2?	N/A
	X Walk 1 Direction	To S		X Walk 2 Direction	N/A
N/A	X Walk 1 Width (in)	102.0	N/A	X Walk 2 Width (in)	N/A
	X Walk 1 Slope (%)	2.0		X Walk 2 Slope (%)	N/A
	X Walk 1 X Slope (%)	1.4		X Walk 2 X Slope (%)	N/A

N/A	Ramp inside XWalk1?	Yes	N/A	Ramp inside XWalk2?	N/A
	Road Slope (%)	N/A	N/A	Clear Space?	N/A
	Road X Slope (%)	N/A	N/A	Clear Space to XWalk (in)	N/A
N/A	Any Obstructions?	N/A	N/A	Storm Grate/Utility Hazard?	N/A
	Obstruction Type			Storm Grate/Utility Type	
		N/A			N/A
		Yes		Surface Condition? (G/P)	Good

Possible Solutions:

Remove & Replace Entire Ramp.

R304.2.2

\$ 3400.00
