Access Compliance Report Public Rights-of-Way (Curb Ramps)

Intersection ID: 7169 Main Street: MILBURN_CT Cross Street: TILDEN_RD Location: N **Overall Compliance: No** ADA ID: 5A2D896F81A4 Ramp Type: Perp Initial Pass/Fail: Fail **Severity Score:** 8.75

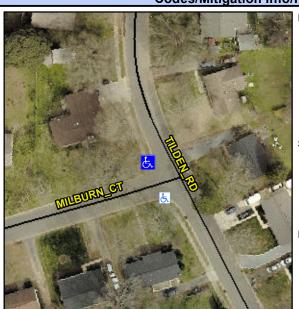
Field Measurements/Component Compliance								
Compl	iance Description	Data	Comp	liance	Description	Data		
N/A	Ramp Length (in)	48.0	Yes	Ram	Slope (%)	7.8		
No	Ramp Width (in)	36.0	Yes	Ram	XSlope (%)	0.9		
N/A	Flare Type LT	N/A	N/A	Flare	Type RT	N/A		
N/A	Flare Slope LT (%)	N/A	N/A	Flare	Slope RT (%)	N/A		
N/A	Flare Traversable LT?	N/A	N/A	Flare	Traversable RT?	N/A		
N/A	Landing Length (in)	N/A	N/A	DWS	Provided?	N/A		
N/A	Landing Width (in)	N/A	N/A	DWS	Contrast?	N/A		
N/A	Landing Slope (%)	N/A	N/A	DWS	Length (in)	N/A		
N/A	Landing X Slope (%)	N/A	N/A	DWS	Full Width?	N/A		
N/A	Landing Curb? (Y/N)	N/A	N/A	DWS	Offset (in)	N/A		
N/A	Shared Landing?	N/A						
N/A	Gutter Ponding?	N/A	N/A	Gutte	er Slope (%)	N/A		
N/A	Gutter Lip Ht (in)	N/A	N/A	Gutte	er X Slope (%)	N/A		
N/A	Painted X Walk1?	No	N/A	Paint	ed X Walk2?	N/A		
	X Walk 1 Direction	To S		X Wa	lk 2 Direction	N/A		
N/A	X Walk 1 Width (in)	N/A	N/A	X Wa	ılk 2 Width (in)	N/A

X Walk 1 Slope (%)	1.4		X Wa	lk 2 Slope (%)	N/A		
	X Walk 1 X Slope (%)	1.2		X Wa	lk 2 X Slope (%)	N/A		
N/A	Ramp inside XWalk1?	N/A	N/A	Ram	o inside XWalk2?	N/A		
	Road Slope (%)	N/A	N/A	Clear	Space?	N/A		
	Road X Slope (%)	N/A	N/A	Clear	Space to XWalk (in)	N/A		
N/A	Any Obstructions?	N/A	N/A	Storn	n Grate/Utility Hazard?	N/A		
	Obstruction Type			Storn	n Grate/Utility Type			
		N/A				N/A		
			Yes	Surfa	ce Condition? (G/P)	Good

Possible Solutions:	C			
Remove & Replace Entire Ramp.				
·	No			
	N/			
Surveyor Notes:	N/			
N/A	N/			
	N/			
	N/			
	N/			
PROW/ADA:	N/			
Not Found, R304.5.1	N/			
	N/			
	N/
