Access Compliance Report

Public Rights-of-Way

(Curb Ramps)

| Intersection ID: 14618 | Main Street: UNNAMED_ST | Cross Street: WINTERFIELD_PL | Location: E |

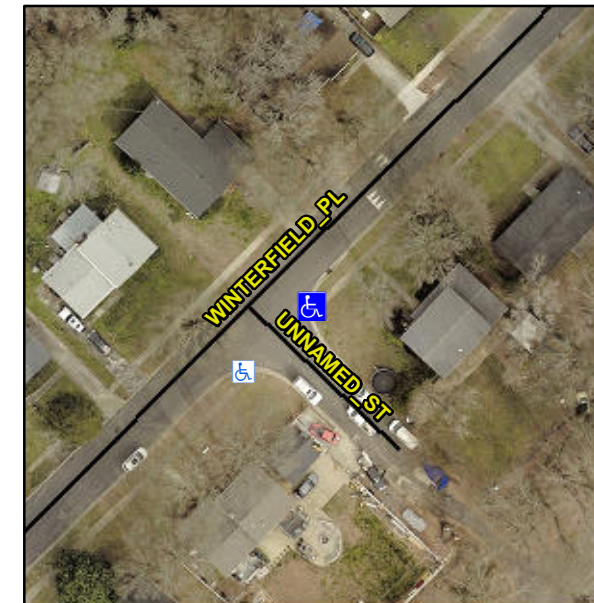
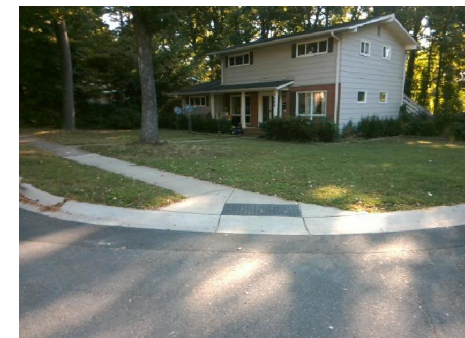
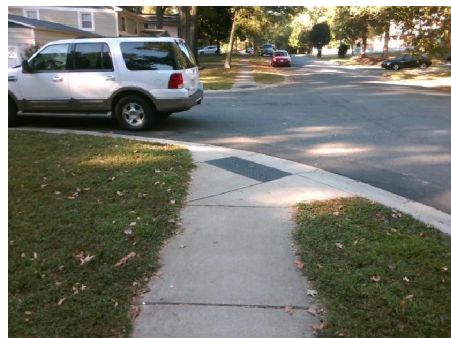
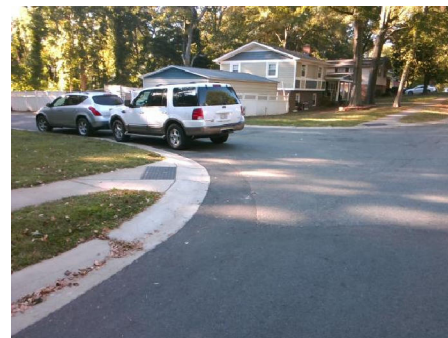
| ADA ID: 5A30E32FE165 | Ramp Type: BlendTrans1 | Initial Pass/Fail: Fail | Overall Compliance: No |
| | | Severity Score: 8.75 | |

Not Found, R304.5.1

| Compliance | Description | Data | Compliance | Description | Data |
|---|---|---|---|---|---|
| No | Ramp Width (in) | 47.5 | Yes | BlendTrans XSlope (%) | 2.0 |
| | | | No | Curb Slope (%) | 15.8 |

Remove & Replace Curb Ramp With Two New Directional Ramps or Equivalent.
