Access Compliance Report Public Rights-of-Way (Curb Ramps)

Intersection ID: 30049 Main Street: SUMMER_COACH_DR Cross Street: SUNSET_VILLAGE_DR Location: NW
ADA ID: 5A37515913CC Ramp Type: Combination1Diag Initial Pass/Fail: Fail Overall Compliance: No Severity Score: 0

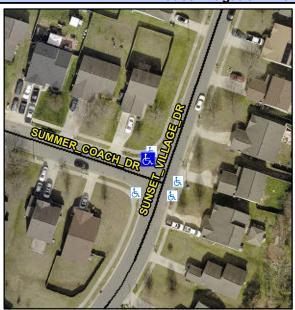
Ramp Length LT (in) N/A Ramp Length RT (in) N/A 37.5 46.5 No No Ramp Width LT (in) Ramp Width RT (in) 6.2 No Yes Ramp Slope LT (%) Ramp Slope RT (%) Ramp XSlope LT (%) 2.5 Yes Ramp XSlope RT (%) No N/A Ramp Length (in) 49.0 Nο Ramp Slope (%) 42.0 No Ramp XSlope (%) No Ramp Width (in) N/A Flare Type LT N/A N/A Flare Type RT N/A N/A N/A Flare Slope LT (%) Flare Slope RT (%) N/A Flare Traversable LT? N/A N/A Flare Traversable RT? N/A Landing Length (in) N/A N/A DWS Provided? N/A N/A **DWS Contrast?** N/A Landing Width (in) N/A Landing Slope (%) N/A N/A DWS Length (in) N/A Landing X Slope (%) N/A N/A DWS Full Width? N/A Landing Curb? (Y/N) N/A N/A DWS Offset (in) N/A Shared Landing? N/A N/A **Gutter Ponding?** N/A N/A Gutter Slope (%) N/A N/A Gutter Lip Ht (in) N/A Gutter X Slope (%) N/A N/A Painted X Walk1? No Painted X Walk2? To S X Walk 1 Direction X Walk 2 Direction X Walk 1 Width (in) N/A X Walk 2 Width (in) 5.9 X Walk 2 Slope (%) X Walk 1 Slope (%) X Walk 1 X Slope (%) 3.2 X Walk 2 X Slope (%) N/A N/A N/A Ramp inside XWalk1? Ramp inside XWalk2? Road Slope (%) 5.8 Clear Space?

Remove & Replace Curb Ramp With Two New Directional Ramps or Equivalent.

R304.5.1, R304.5.1, R304.2.2, R304.5.3, R304.3.2

t: \$ 3200.00
