# Access Compliance Report

## Public Rights-of-Way

### (Curb Ramps)

Intersection ID: 14033	Main Street: ELMIN_ST	Cross Street: MORNING_DR	Location: SW
ADA ID: 5A38BFC0648C	Ramp Type: Combination1Diag	Initial Pass/Fail: Fail	Overall Compliance: No
		Severity Score: 0

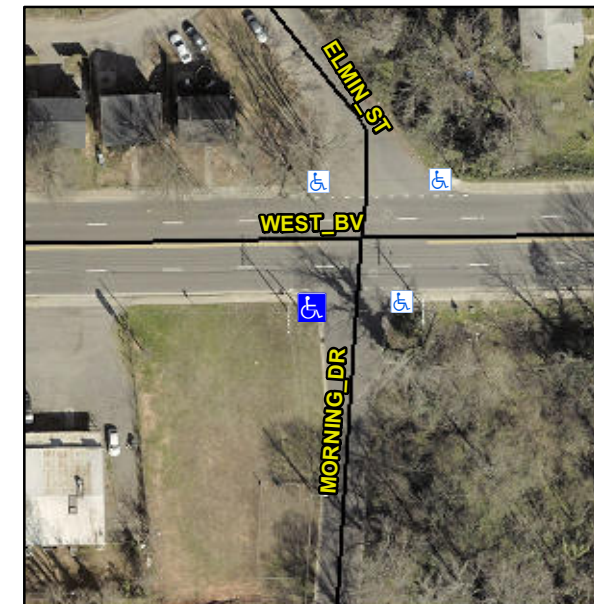
**LT RP < 5%**

**Not Found, R304.5.1, R304.5.1, R304.5.3, R304.3.2**

Compliance	Description	Data	Compliance	Description	Data
N/A	Ramp Length LT (in)	38.0	N/A	Ramp Length RT (in)	43.0
Yes	Ramp Width LT (in)	49.0	No	Ramp Width RT (in)	40.0
Yes	Ramp Slope LT (%)	1.5	No	Ramp Slope RT (%)	10.2
No	Ramp XSlope LT (%)	4.7	No	Ramp XSlope RT (%)	5.2
N/A	Ramp Length (in)	51.0	Yes	Ramp Slope (%)	3.0
No	Ramp Width (in)	46.0	Yes	Ramp XSlope (%)	1.7
N/A	Flare Type LT	N/A	N/A	Flare Type RT	N/A
N/A	Flare Slope LT (%)	N/A	N/A	Flare Slope RT (%)	N/A
N/A	Flare Traversable LT?	N/A	N/A	Flare Traversable RT?	N/A
N/A	Landing Length (in)	N/A	N/A	DWS Provided?	N/A
N/A	Landing Width (in)	N/A	N/A	DWS Contrast?	N/A
N/A	Landing Slope (%)	N/A	N/A	DWS Length (in)	N/A
N/A	Landing X Slope (%)	N/A	N/A	DWS Full Width?	N/A
N/A	Landing Curb? (Y/N)	N/A	N/A	DWS Offset (in)	N/A
N/A	Shared Landing?	N/A			
N/A	Gutter Ponding?	N/A	N/A	Gutter Slope (%)	N/A
N/A	Gutter Lip Ht (in)	N/A	N/A	Gutter X Slope (%)	N/A
N/A	Painted X Walk1?	No	N/A	Painted X Walk2?	No

X Walk 1 Direction	To E		X Walk 2 Direction	To N
	X Walk 1 Width (in)	N/A		X Walk 2 Width (in)	N/A
	X Walk 1 Slope (%)	1.9		X Walk 2 Slope (%)	3.2
	X Walk 1 X Slope (%)	0.9		X Walk 2 X Slope (%)	3.1
N/A	Ramp inside XWalk1?	N/A	N/A	Ramp inside XWalk2?	N/A
	Road Slope (%)	2.0		Clear Space?	N/A
	Road X Slope (%)	1.3	N/A	Clear Space to XWalk (in)	N/A
			N/A	Any Obstruction?	N/A
				Obstruction Type	N/A
			N/A	Storm Grate/Utility Hazard?	N/A
				Storm Grate/Utility Type	N/A
Yes	Surface Condition? (G/P)	Good			
	Curb Slope (%)	9.0

**Remove & Replace Curb Ramp With Two New Directional Ramps or Equivalent.**
