Access Compliance Report

Public Rights-of-Way

(Curb Ramps)

Intersection ID: 5646	Main Street: MCCULLOUGH_DR	Cross Street: COLLINS-AIKMAN_DR	Location:	E
ADA ID: 5A38D14757DF	Ramp Type: PerpDiag	Initial Pass/Fail: Fail	Overall Compliance: No	Severity Score: 8.75

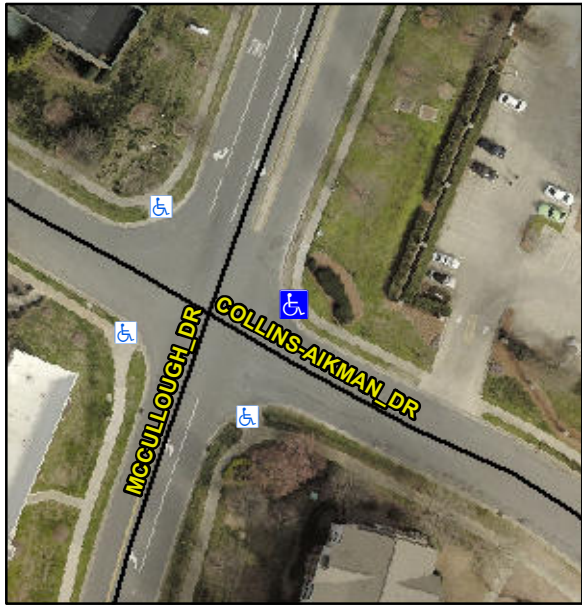
<div>Street 1 Name<div>MCCULLOUGH DR</div></div> <div>Stop Condition-Street 2<div>None</div></div> <div>Street 2 Name<div>COLLINS AIKMAN DR</div></div> <div>Stop Condition-Street 1<div>StopSign</div></div>	Possible Solutions:		Compliance	Description	Data	Compliance	Description	Data
	Remove & Replace Curb Ramp With Two New Directional Ramps or Equivalent.		N/A	Ramp Length (in)	52.5	Yes	Ramp Slope (%)	7.3
			No	Ramp Width (in)	40.0	Yes	Ramp XSlope (%)	1.8
			N/A	Flare Type LT	N/A	N/A	Flare Type RT	N/A
			N/A	Flare Slope LT (%)	N/A	N/A	Flare Slope RT (%)	N/A
			N/A	Flare Traversable LT?	N/A	N/A	Flare Traversable RT?	N/A
			N/A	Landing Length (in)	N/A	N/A	DWS Provided?	N/A
			N/A	Landing Width (in)	N/A	N/A	DWS Contrast?	N/A
			N/A	Landing Slope (%)	N/A	N/A	DWS Length (in)	N/A
			N/A	Landing X Slope (%)	N/A	N/A	DWS Full Width?	N/A

Surveyor Notes:		N/A	N/A	Landing Curb? (Y/N)	N/A	N/A	DWS Offset (in)	N/A
PROW/ADA:		Not Found, R304.5.1	N/A	Shared Landing?	N/A			
			N/A	Gutter Ponding?	N/A	N/A	Gutter Slope (%)	N/A
			N/A	Gutter Lip Ht (in)	N/A	N/A	Gutter X Slope (%)	N/A
			N/A	Painted X Walk1?	No	N/A	Painted X Walk2?	No
				X Walk 1 Direction	To NW		X Walk 2 Direction	To SW
			N/A	X Walk 1 Width (in)	N/A	N/A	X Walk 2 Width (in)	N/A
				X Walk 1 Slope (%)	7.8		X Walk 2 Slope (%)	5.6
				X Walk 1 X Slope (%)	4.0		X Walk 2 X Slope (%)	5.1
			N/A	Ramp inside XWalk1?	N/A	N/A	Ramp inside XWalk2?	N/A
				Road Slope (%)	1.2	N/A	Clear Space?	N/A
				Road X Slope (%)	7.0	N/A	Clear Space to XWalk (in)	N/A
			N/A	Any Obstructions?	N/A	N/A	Storm Grate/Utility Hazard?	N/A
				Obstruction Type			Storm Grate/Utility Type	
					N/A			N/A
						Yes	Surface Condition? (G/P)	Good
Total Cost:		\$ 3200.00
